# Home Report

# Energy Performance Certificate (EPC)

**NORTHFIELD, NORTH HERMITAGE STREET, NEWCASTLETON, TD9 0RG**

# Single Survey

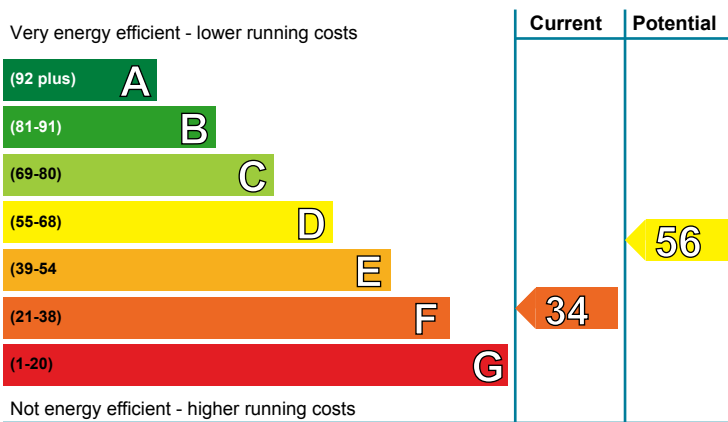
## Energy Efficiency Rating

This graph shows the current efficiency of your home, taking into account both energy efficiency and fuel costs. The higher this rating, the lower your fuel bills are likely to be.

Your current rating is **band F (34)**. The average rating for EPCs in Scotland is **band D (61)**.

The potential rating shows the effect of undertaking all of the improvement measures listed within your recommendations report.

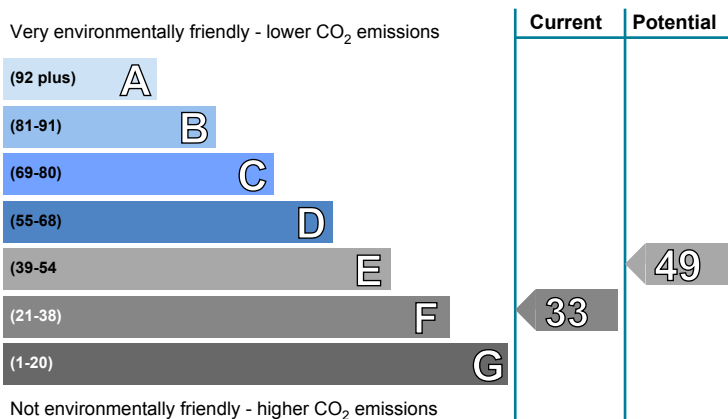
## Environmental Impact (CO<sub>2</sub>) Rating

This graph shows the effect of your home on the environment in terms of carbon dioxide (CO<sub>2</sub>) emissions. The higher the rating, the less impact it has on the environment.

The potential rating shows the effect of undertaking all of the improvement measures listed within your recommendations report.
