# Home Report

# Single Survey

<b>Property address</b>	30a Salters Road Wallyford Musselburgh EH21 8AA
<b>Customer</b>	[REDACTED]
<b>Customer address</b>	30a Salters Road Wallyford Musselburgh EH21 8AA
<b>Prepared by</b>	Shepherd Chartered Surveyors
<b>Date of inspection</b>	11/06/2025

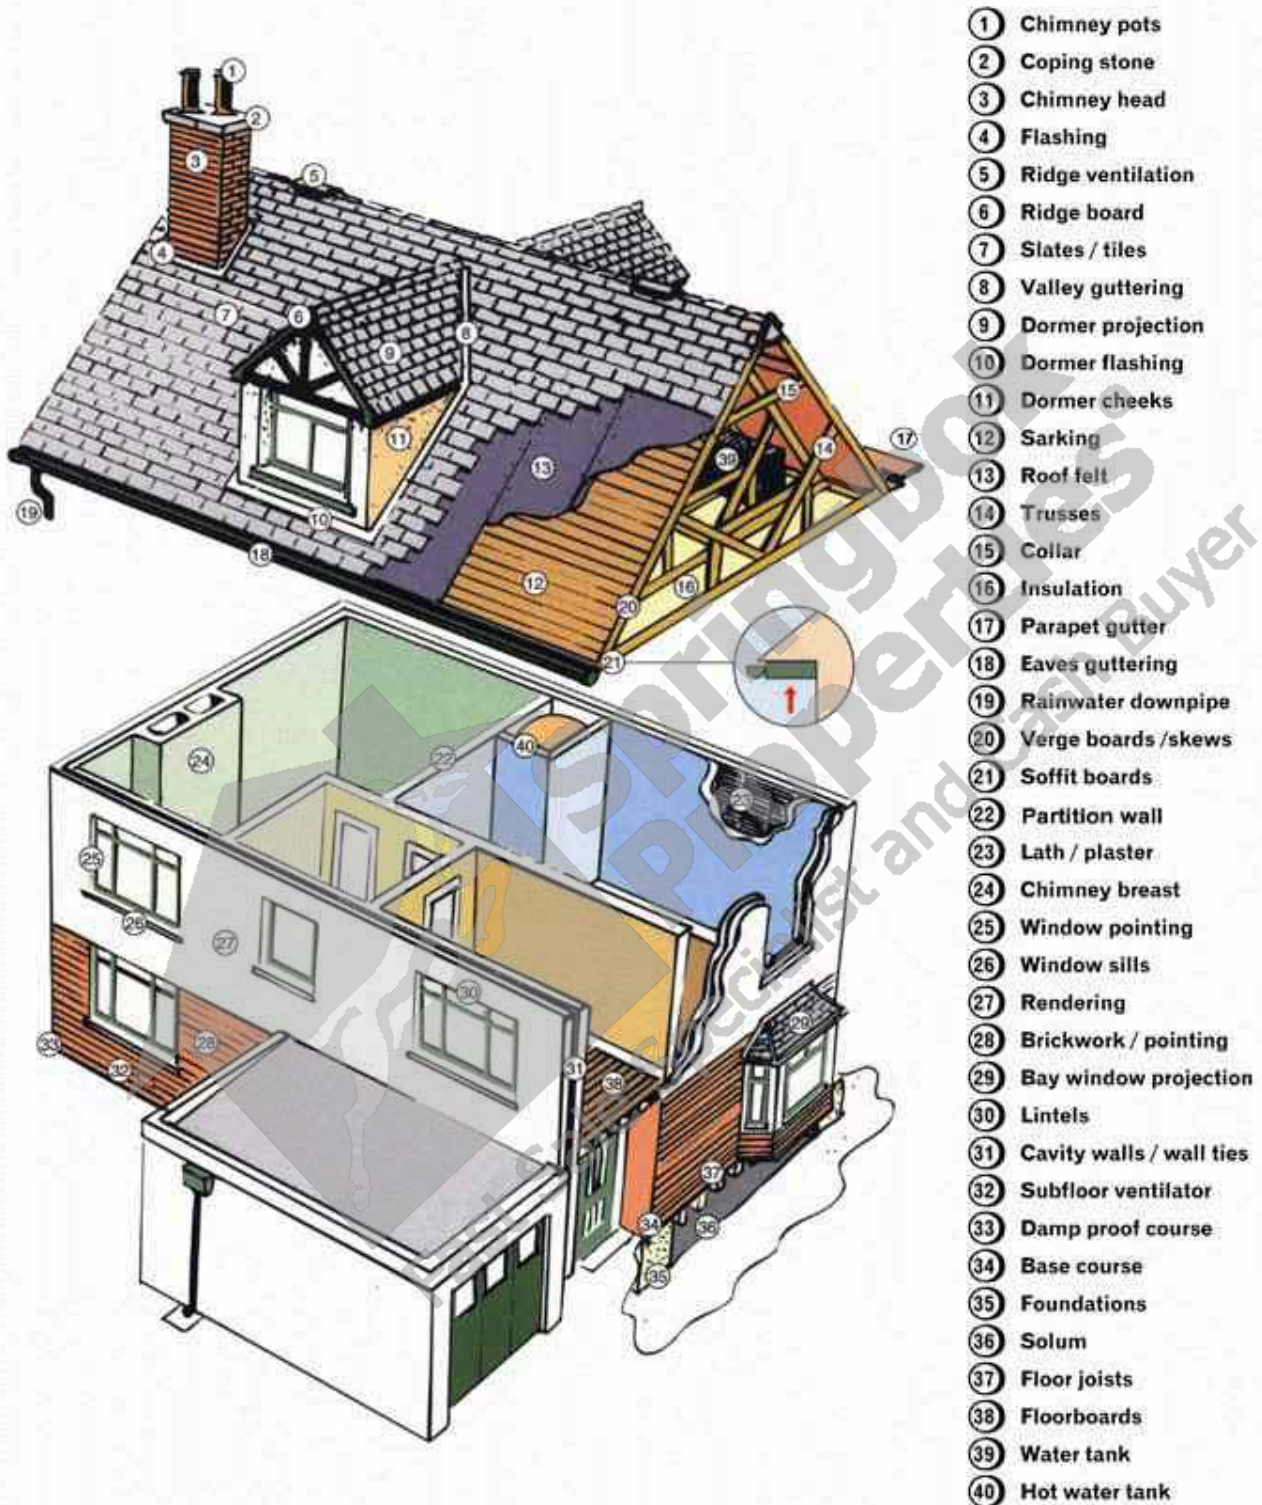
## Sectional Diagram showing elements of a typical house

Reference may be made in this report to some or all of the above component parts of the property. This diagram may assist you in locating and understanding these items.

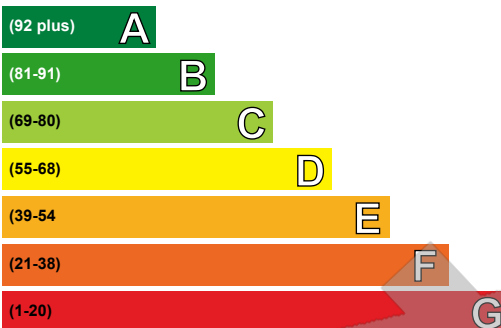
## Energy Efficiency Rating

Very energy efficient - lower running costs

Current	Potential
63	84

Not energy efficient - higher running costs

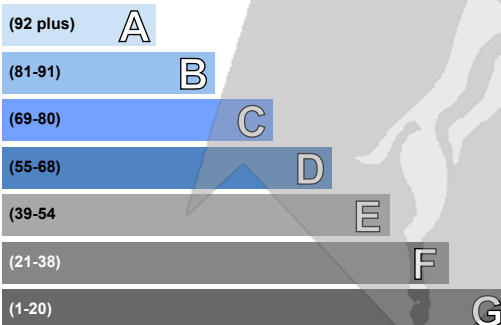
## Environmental Impact (CO<sub>2</sub>) Rating

Very environmentally friendly - lower CO<sub>2</sub> emissions

Current	Potential
56	80
