Home Report

Single Survey

Property address	42 Fife Street Keith AB55 5EG
Customer	[REDACTED]
Customer address	42 Fife Street Keith AB55 5EG
Prepared by	Shepherd Chartered Surveyors
Date of inspection	09/01/2025

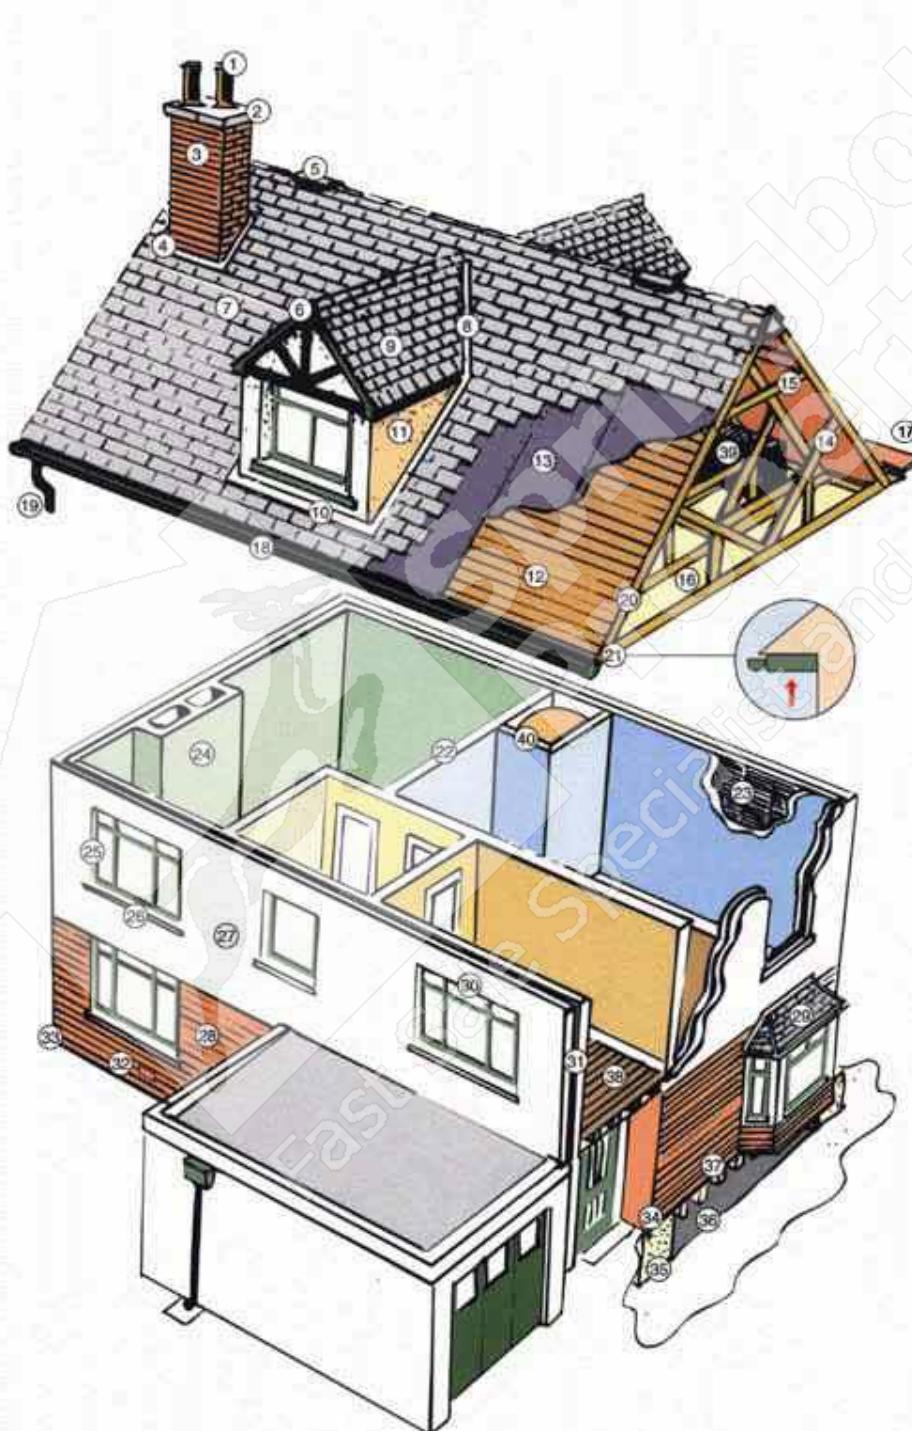
Sectional Diagram showing elements of a typical house

- 1 Chimney pots
- 2 Coping stone
- 3 Chimney head
- 4 Flashing
- 5 Ridge ventilation
- 6 Ridge board
- 7 Slates / tiles
- 8 Valley guttering
- 9 Dormer projection
- 10 Dormer flashing
- 11 Dormer cheeks
- 12 Sarking
- 13 Roof felt
- 14 Trusses
- 15 Collar
- 16 Insulation
- 17 Parapet gutter
- 18 Eaves guttering
- 19 Rainwater downpipe
- 20 Verge boards /skews
- 21 Soffit boards
- 22 Partition wall
- 23 Lath / plaster
- 24 Chimney breast
- 25 Window pointing
- 26 Window sills
- 27 Rendering
- 28 Brickwork / pointing
- 29 Bay window projection
- 30 Lintels
- 31 Cavity walls / wall ties
- 32 Subfloor ventilator
- 33 Damp proof course
- 34 Base course
- 35 Foundations
- 36 Solum
- 37 Floor joists
- 38 Floorboards
- 39 Water tank
- 40 Hot water tank

Reference may be made in this report to some or all of the above component parts of the property. This diagram may assist you in locating and understanding these items.
