HOME REPORT

64 Gillway
Rosyth, Dunfermline
KY11 2UL

Single Survey

Surveyor Reference	DD3050
Customer	Mr. David Foote
Selling address	64 Gillway Rosyth, Dunfermline KY11 2UL
Date of Inspection	09/01/2026
Prepared by	Jonathan Combe, BSc (Hons) MRICS Dunfermline - Allied Surveyors Scotland Ltd

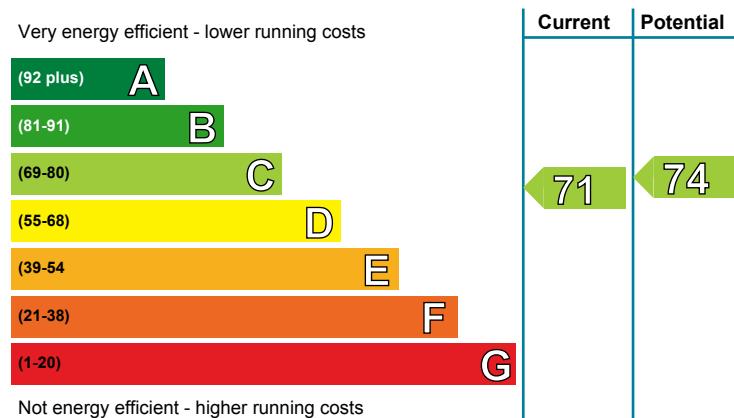
Energy Efficiency Rating

This graph shows the current efficiency of your home, taking into account both energy efficiency and fuel costs. The higher this rating, the lower your fuel bills are likely to be.

Your current rating is **band C (71)**. The average rating for EPCs in Scotland is **band D (61)**.

The potential rating shows the effect of undertaking all of the improvement measures listed within your recommendations report.

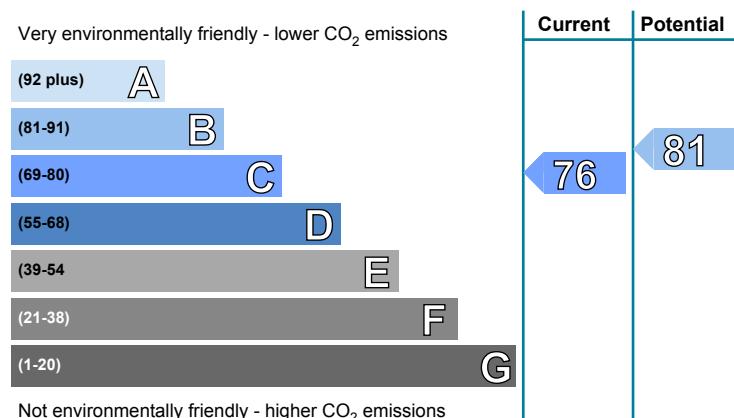
Environmental Impact (CO₂) Rating

This graph shows the effect of your home on the environment in terms of carbon dioxide (CO₂) emissions. The higher the rating, the less impact it has on the environment.
