# Home Report

# Single Survey

| <b>Property address</b> | 0/2<br>2 Clavering Street West<br>Paisley<br>PA1 2PX |

| <b>Prepared by</b> | Shepherd Chartered Surveyors |

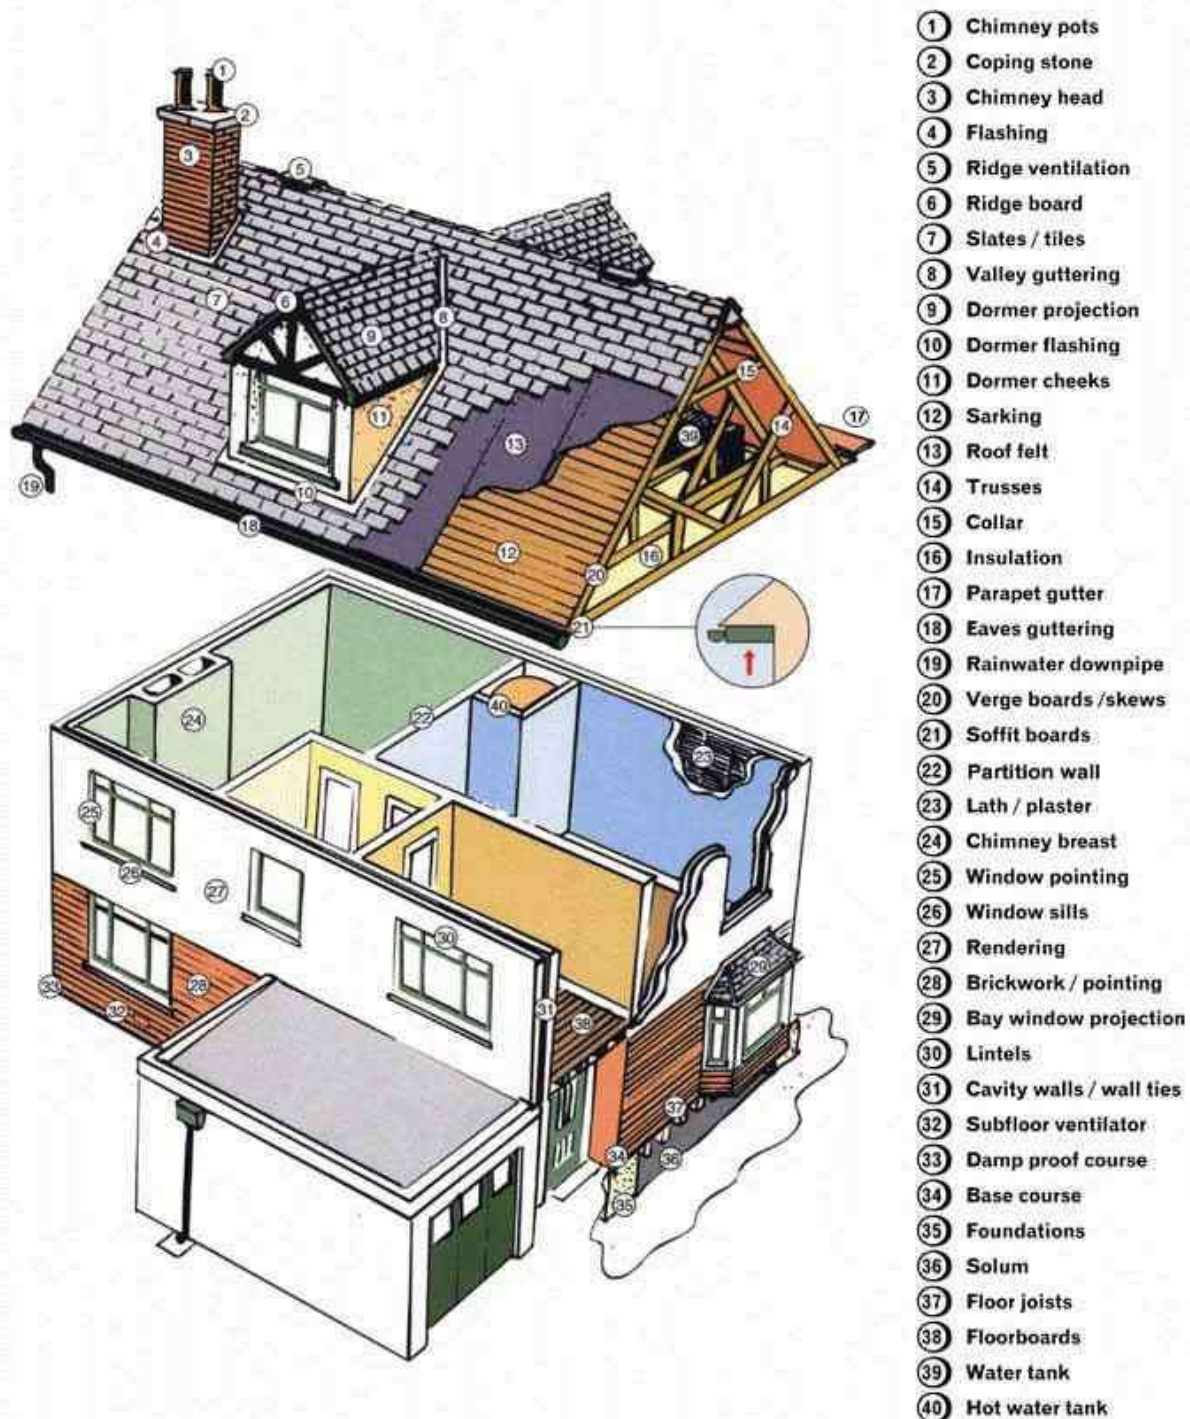
## Sectional Diagram showing elements of a typical house

Reference may be made in this report to some or all of the above component parts of the property. This diagram may assist you in locating and understanding these items.

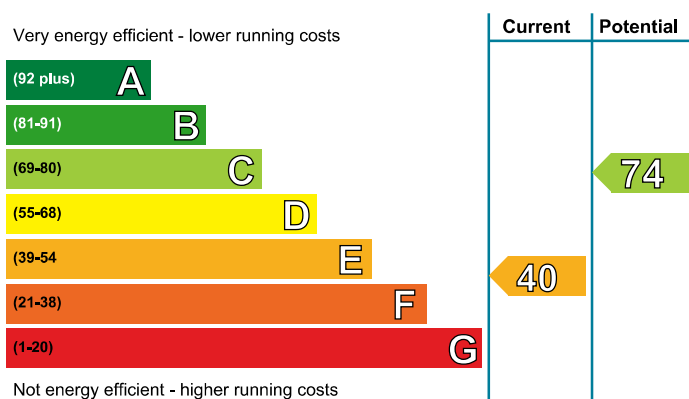
## Energy Efficiency Rating

This graph shows the current efficiency of your home, taking into account both energy efficiency and fuel costs. The higher this rating, the lower your fuel bills are likely to be.

Your current rating is **band E (40)**. The average rating for EPCs in Scotland is **band D (61)**.

The potential rating shows the effect of undertaking all of the improvement measures listed within your recommendations report.

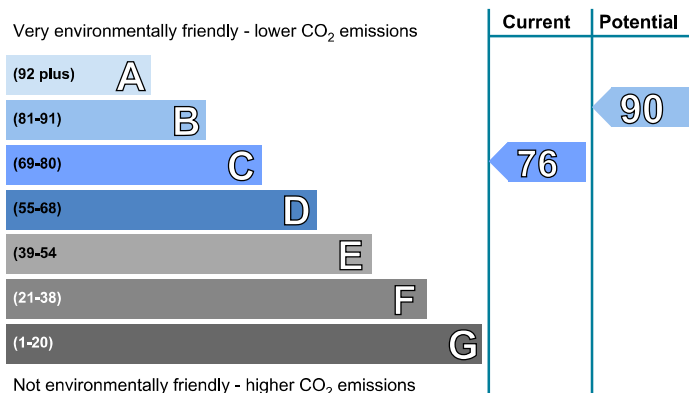
## Environmental Impact (CO<sub>2</sub>) Rating

This graph shows the effect of your home on the environment in terms of carbon dioxide (CO<sub>2</sub>) emissions. The higher the rating, the less impact it has on the environment.
