HOME REPORT

CRUACHAN
6 GLASPHEIN
STAFFIN
PORTREE
IV51 9JZ

Energy Performance Certificate (EPC)

Cruachan, 6 Glasphein, Staffin, Portree, IV51 9JZ

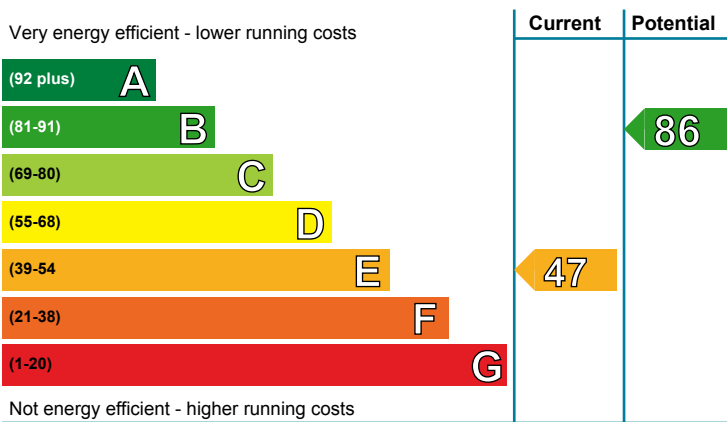
Energy Efficiency Rating

This graph shows the current efficiency of your home, taking into account both energy efficiency and fuel costs. The higher this rating, the lower your fuel bills are likely to be.

Your current rating is **band E (47)**. The average rating for EPCs in Scotland is **band D (61)**.

The potential rating shows the effect of undertaking all of the improvement measures listed within your recommendations report.

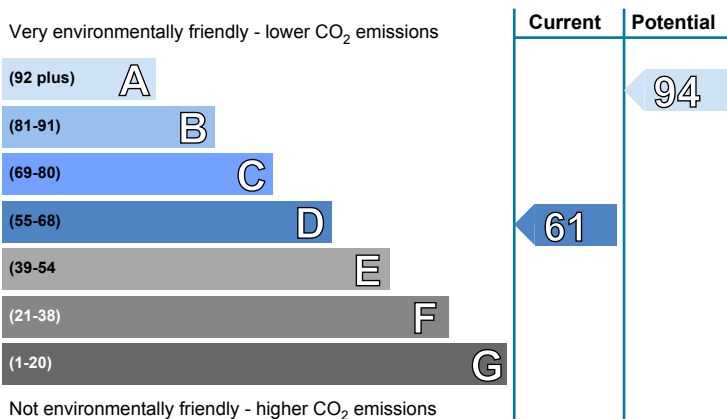
Environmental Impact (CO₂) Rating

This graph shows the effect of your home on the environment in terms of carbon dioxide (CO₂) emissions. The higher the rating, the less impact it has on the environment.

Your current rating is **band D (61)**. The average rating for EPCs in Scotland is **band D (59)**.

The potential rating shows the effect of undertaking all of the improvement measures listed within your recommendations report.
