HOME
report

SINGLE SURVEY
ENERGY REPORT
PROPERTY QUESTIONNAIRE
VALUATION REPORT

Single Survey

Property Address	61 Lochan Road Kilsyth Glasgow G65 0ES
Customer	Mr J Fitzsimmons & Mrs D Fitzsimmons
Date of Inspection	23/06/2026
Prepared by	Duncan Somerville Harvey Donaldson & Gibson Chartered Surveyors

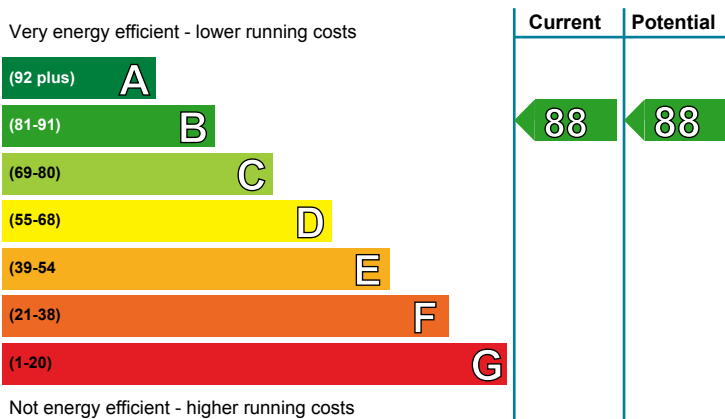
Energy Efficiency Rating

This graph shows the current efficiency of your home, taking into account both energy efficiency and fuel costs. The higher this rating, the lower your fuel bills are likely to be.

Your current rating is **band B (88)**. The average rating for EPCs in Scotland is **band D (61)**.

The potential rating shows the effect of undertaking all of the improvement measures listed within your recommendations report.
