Home Report

Single Survey

25 Yeamans Alley,
Dundee,
Angus,
DD2 3DW

DD202601-48182

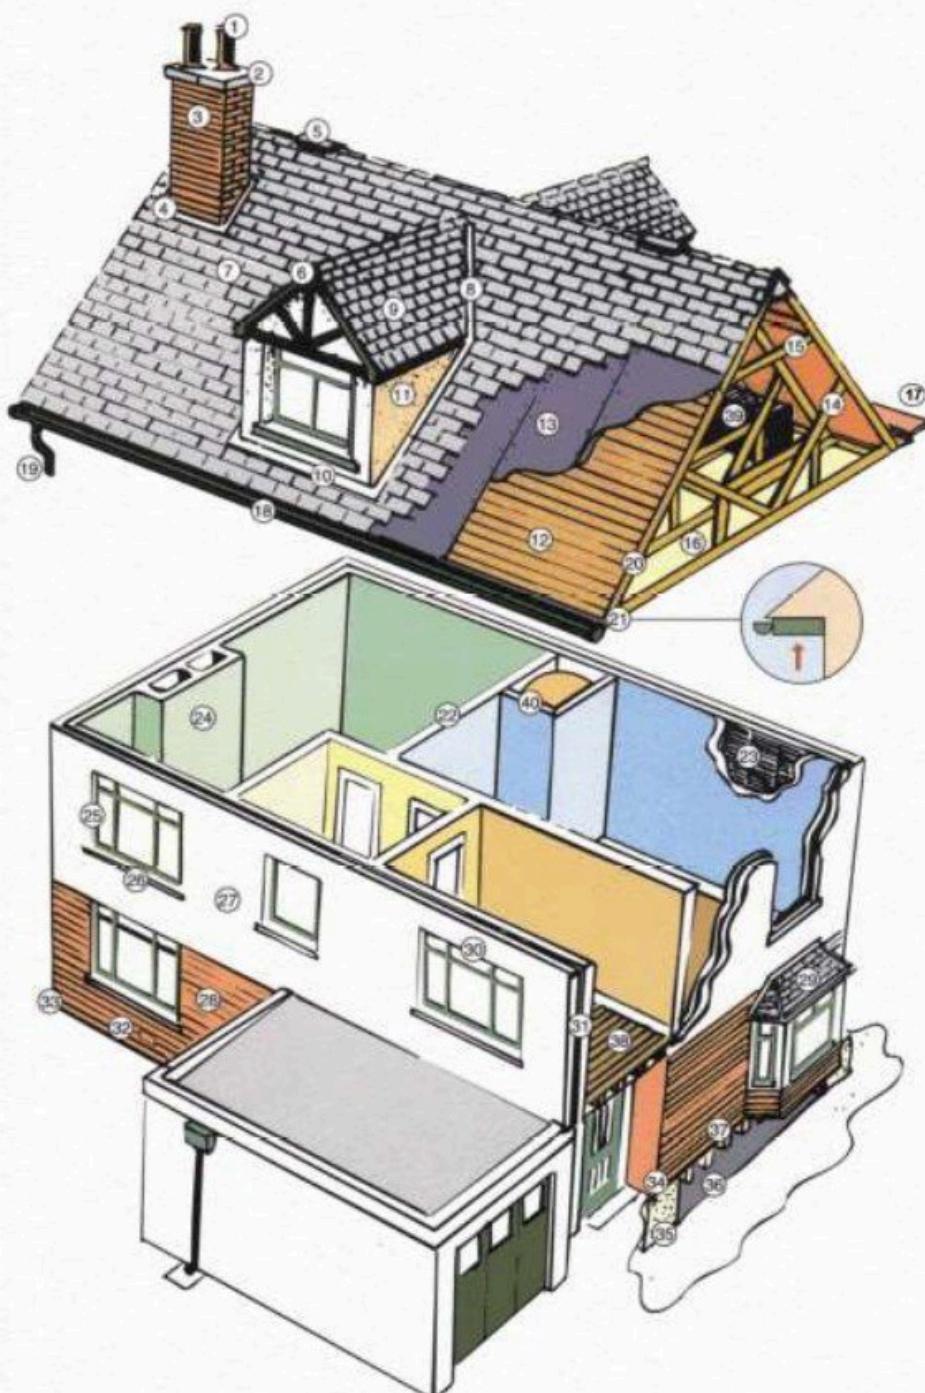
Sectional Diagram showing elements of a typical house

- 1 Chimney pots
- 2 Coping stone
- 3 Chimney head
- 4 Flashing
- 5 Ridge ventilation
- 6 Ridge board
- 7 Slates / tiles
- 8 Valley guttering
- 9 Dormer projection
- 10 Dormer flashing
- 11 Dormer cheeks
- 12 Sarking
- 13 Roof felt
- 14 Trusses
- 15 Collar
- 16 Insulation
- 17 Parapet gutter
- 18 Eaves guttering
- 19 Rainwater downpipe
- 20 Verge boards / skewers
- 21 Soffit boards
- 22 Partition wall
- 23 Lath / plaster
- 24 Chimney breast
- 25 Window pointing
- 26 Window sills
- 27 Rendering
- 28 Brickwork / pointing
- 29 Bay window projection
- 30 Lintels
- 31 Cavity walls / wall ties
- 32 Subfloor ventilator
- 33 Damp proof course
- 34 Base course
- 35 Foundations
- 36 Solum
- 37 Floor joists
- 38 Floorboards
- 39 Water tank
- 40 Hot water tank

Reference may be made in this report to some or all of the above component parts of the property. This diagram may assist you in locating and understanding these items.

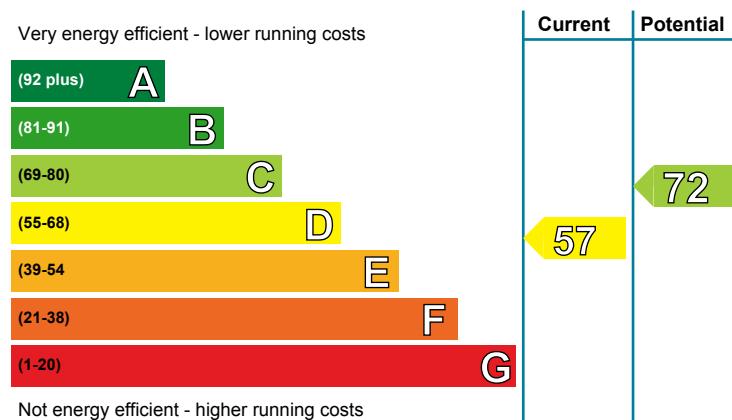
Energy Efficiency Rating

This graph shows the current efficiency of your home, taking into account both energy efficiency and fuel costs. The higher this rating, the lower your fuel bills are likely to be.

Your current rating is **band D (57)**. The average rating for EPCs in Scotland is **band D (61)**.

The potential rating shows the effect of undertaking all of the improvement measures listed within your recommendations report.

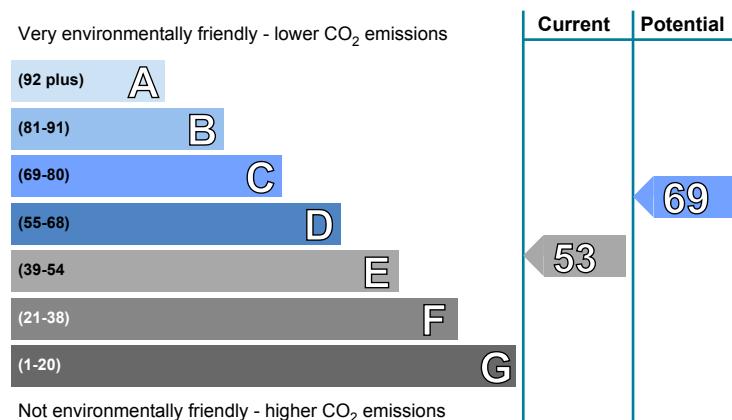
Environmental Impact (CO₂) Rating

This graph shows the effect of your home on the environment in terms of carbon dioxide (CO₂) emissions. The higher the rating, the less impact it has on the environment.
