19 Haining Place,
Grangemouth,
Stirlingshire,
FK3 9DR

Home Report

Single Survey

Property Address	19 Haining Place, Grangemouth, Stirlingshire, FK3 9DR
Reference	1571488
Customer Name	June Johnston
Date of Inspection	11th May 2026
Surveyor's name, qualifications and office	David Telford DM Hall LLP Chartered Surveyors Unit 6A, The Courtyard Callendar Business Park Falkirk FK1 1XR Tel: 01324 628321 email: centralresidential@dmhall.co.uk
Prepared By	DM Hall LLP

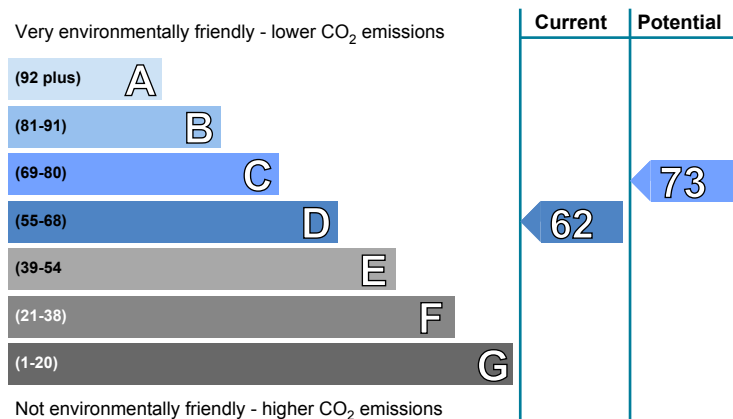
Environmental Impact (CO₂) Rating

This graph shows the effect of your home on the environment in terms of carbon dioxide (CO₂) emissions. The higher the rating, the less impact it has on the environment.
