# Home Report

# Scottish Single Survey

<b>Property address</b>	9 Sharon Street Dalry KA24 5DR
<b>Customer</b>	Dr Catherine Boreland
<b>Customer address</b>	9 Sharon Street Dalry KA24 5DR
<b>Prepared by</b>	Shepherd Chartered Surveyors
<b>Date of inspection</b>	19/09/2025

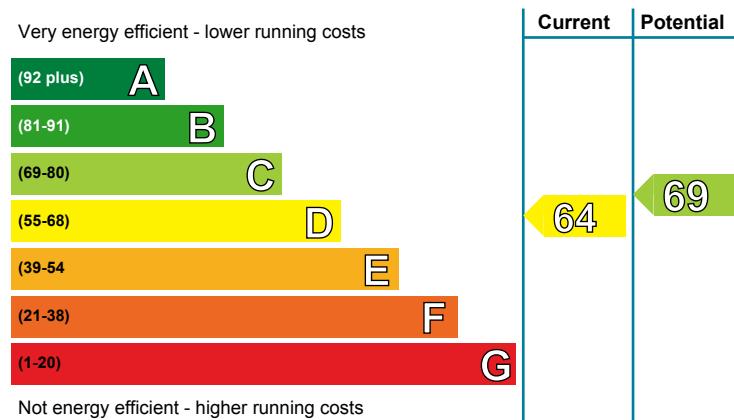
## Energy Efficiency Rating

This graph shows the current efficiency of your home, taking into account both energy efficiency and fuel costs. The higher this rating, the lower your fuel bills are likely to be.

Your current rating is **band D (64)**. The average rating for EPCs in Scotland is **band D (61)**.

The potential rating shows the effect of undertaking all of the improvement measures listed within your recommendations report.

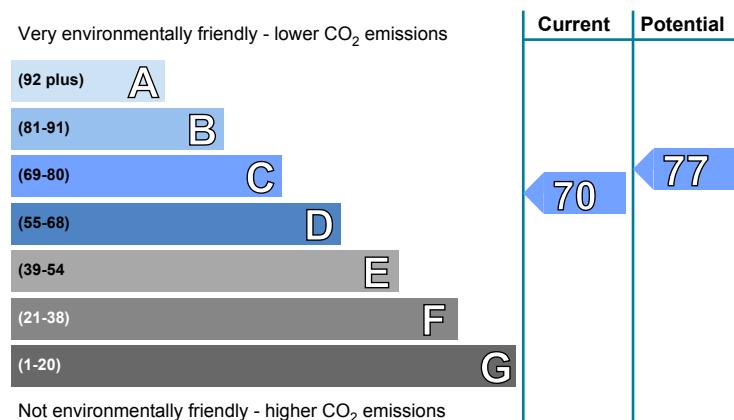
## Environmental Impact (CO<sub>2</sub>) Rating

This graph shows the effect of your home on the environment in terms of carbon dioxide (CO<sub>2</sub>) emissions. The higher the rating, the less impact it has on the environment.
