# YOUR ONESURVEY HOME REPORT

3 County Houses  
Miltonduff  
Elgin  
IV30 8TJ

# SINGLE SURVEY

A report on the condition of the property, with categories  
being rated from 1 to 3.

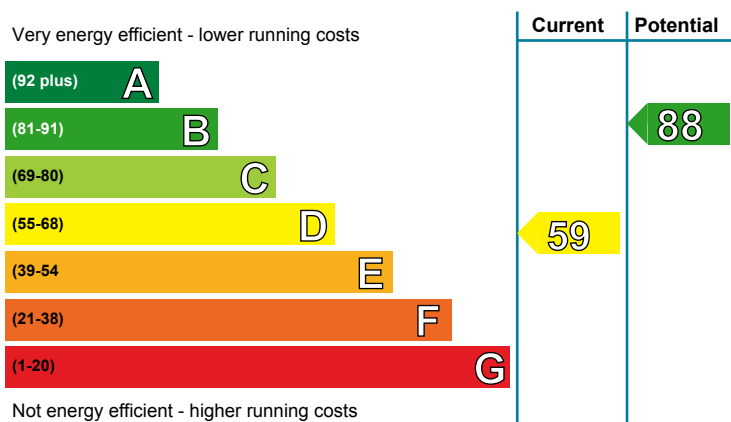
## Energy Efficiency Rating

This graph shows the current efficiency of your home, taking into account both energy efficiency and fuel costs. The higher this rating, the lower your fuel bills are likely to be.

The potential rating shows the effect of undertaking all of the improvement measures listed within your recommendations report.

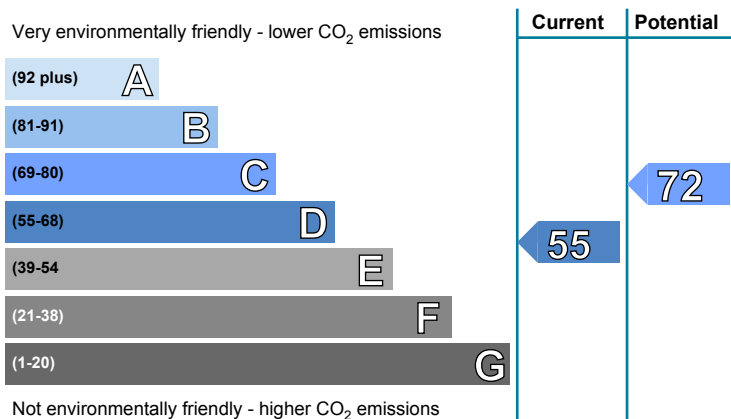
## Environmental Impact (CO<sub>2</sub>) Rating

This graph shows the effect of your home on the environment in terms of carbon dioxide (CO<sub>2</sub>) emissions. The higher the rating, the less impact it has on the environment.
