# Home Report

39 Jamieson Street  
Arbroath DD11 2AY

# Single Survey

<b>Property Address</b>	39 Jamieson Street Arbroath DD11 2AY
<b>Customer</b>	Ms Winifred Hughes
<b>Prepared by</b>	Graham + Sibbald Property Consultants Limited
<b>Date of Inspection</b>	12/03/2026

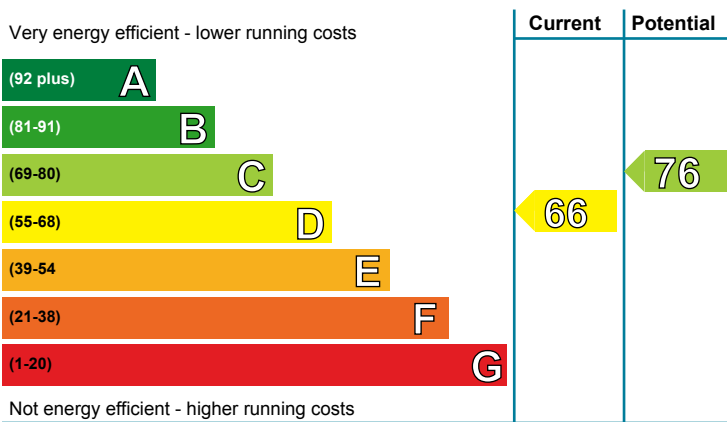
## Energy Efficiency Rating

This graph shows the current efficiency of your home, taking into account both energy efficiency and fuel costs. The higher this rating, the lower your fuel bills are likely to be.

Your current rating is **band D (66)**. The average rating for EPCs in Scotland is **band D (61)**.

The potential rating shows the effect of undertaking all of the improvement measures listed within your recommendations report.
