# Home Report

# Single Survey

<b>Property address</b>	Marview Tarland Aboyne AB34 4TJ
-------------------------	--

<b>Date of inspection</b>	30/03/2026
---------------------------	------------

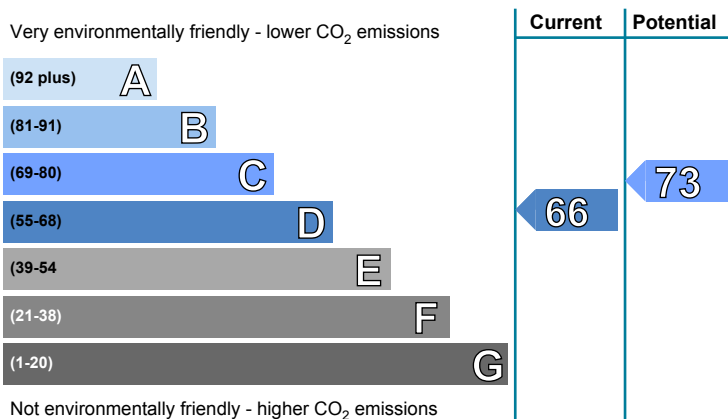
## Environmental Impact (CO<sub>2</sub>) Rating

This graph shows the effect of your home on the environment in terms of carbon dioxide (CO<sub>2</sub>) emissions. The higher the rating, the less impact it has on the environment.
