Home Report

Single Survey

Property address	Sea Mist Kilduskland Road Ardrishaig Lochgilphead PA30 8HE
Customer	Antonie Martantonio
Customer address	Sea Mist Kilduskland Road Ardrishaig Lochgilphead PA30 8HE
Prepared by	Shepherd Chartered Surveyors
Date of inspection	18/12/2024

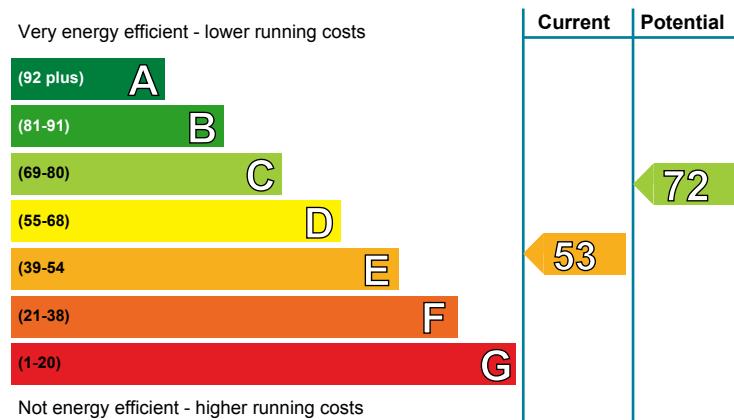
Energy Efficiency Rating

This graph shows the current efficiency of your home, taking into account both energy efficiency and fuel costs. The higher this rating, the lower your fuel bills are likely to be.

Your current rating is **band E (53)**. The average rating for EPCs in Scotland is **band D (61)**.

The potential rating shows the effect of undertaking all of the improvement measures listed within your recommendations report.

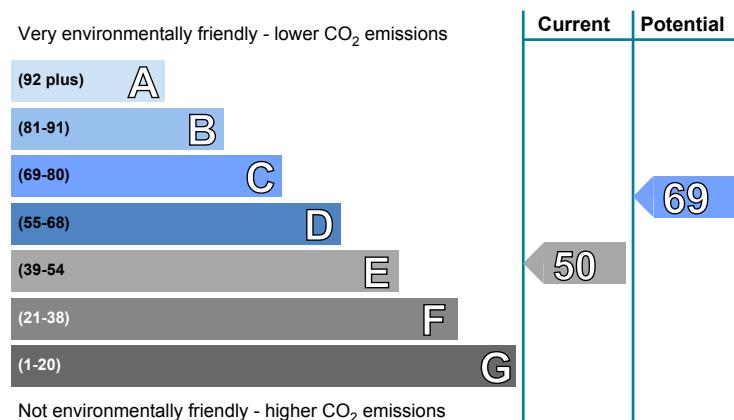
Environmental Impact (CO₂) Rating

This graph shows the effect of your home on the environment in terms of carbon dioxide (CO₂) emissions. The higher the rating, the less impact it has on the environment.
