# Home Report

Calluna  
Dunscore Dumfries DG2 0UJ

# Single Survey

<b>Property Address</b>	Calluna Dunscore Dumfries DG2 0UJ
<b>Customer</b>	Lindsey and David Ferguson
<b>Prepared by</b>	Graham + Sibbald Property Consultants Limited
<b>Date of Inspection</b>	27/03/2026

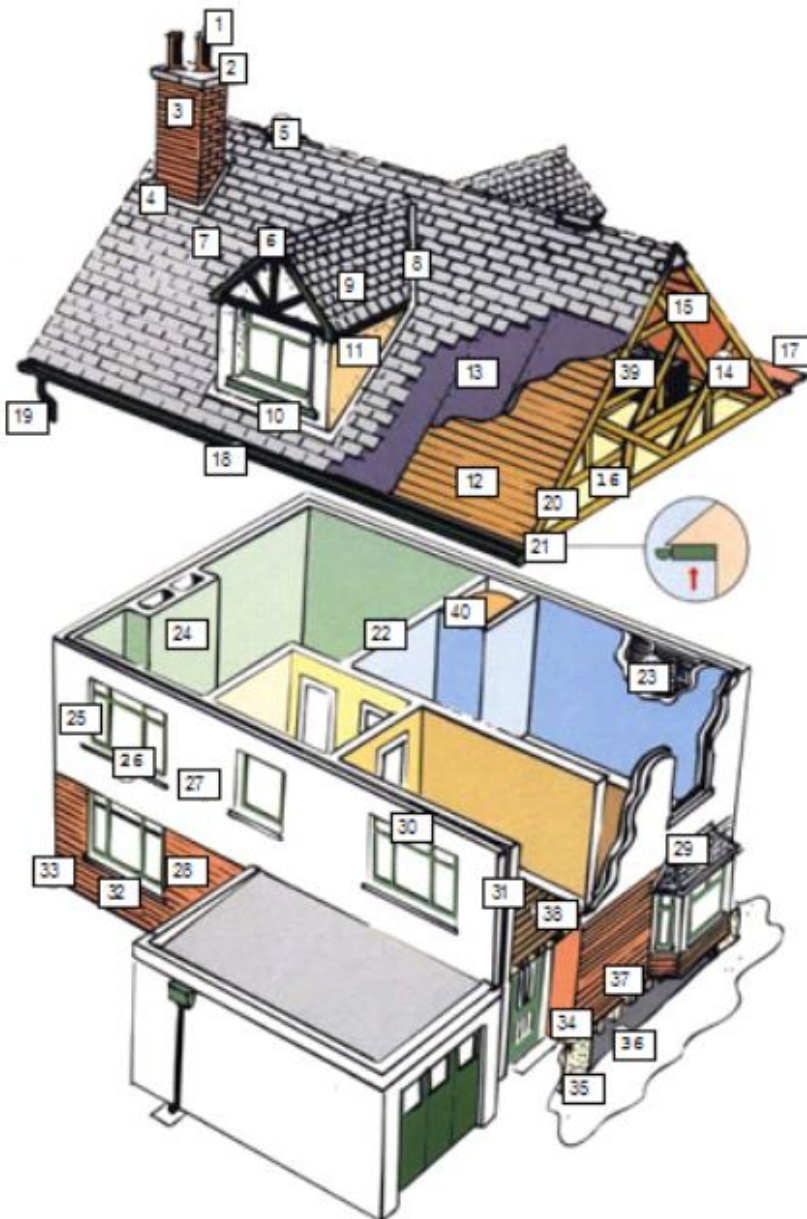
## Sectional diagram showing elements of a typical house

1	Chimney pots
2	Coping stone
3	Chimney head
4	Flashing
5	Ridge ventilation
6	Ridge board
7	Slates / tiles
8	Valley guttering
9	Dormer projection
10	Dormer flashing
11	Dormer cheeks
12	Sarking
13	Roof felt
14	Trusses
15	Collar
16	Insulation
17	Parapet guttering
18	Eaves guttering
19	Rainwater downpipe
20	Verge boards / skews
21	Soffit boards
22	Partition wall
23	Lath / plaster
24	Chimney breast
25	Window pointing
26	Window sills
27	Rendering
28	Brickwork / pointing
29	Bay window projection
30	Lintels
31	Cavity walls / wall ties
32	Subfloor ventilator
33	Damp proof course
34	Base course
35	Foundations
36	Solum
37	Floor joists
38	Floorboards
39	Water tank
40	Hot water tank

Reference may be made in this report to some or all of the above component parts of the property. This diagram may assist you in locating and understanding these items.

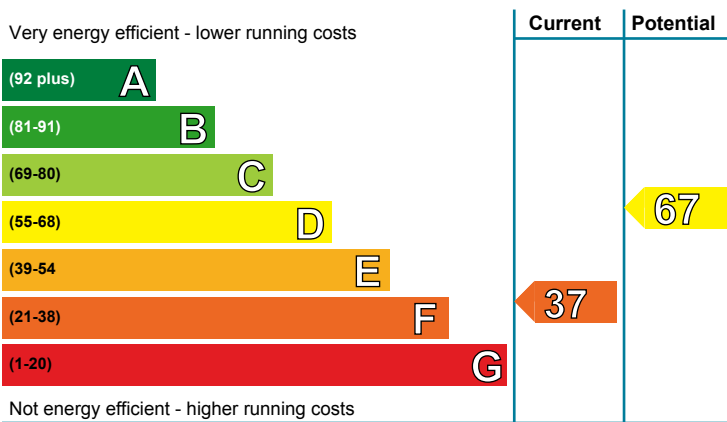
## Energy Efficiency Rating

This graph shows the current efficiency of your home, taking into account both energy efficiency and fuel costs. The higher this rating, the lower your fuel bills are likely to be.

Your current rating is **band F (37)**. The average rating for EPCs in Scotland is **band D (61)**.

The potential rating shows the effect of undertaking all of the improvement measures listed within your recommendations report.
