# Home Report

# Single Survey

<b>Property address</b>	5 Springhill Crescent Douglas Lanark ML11 0PA
<b>Customer</b>	[REDACTED]
<b>Customer address</b>	5 Springhill Crescent Douglas Lanark ML11 0PA
<b>Prepared by</b>	Shepherd Chartered Surveyors
<b>Date of inspection</b>	12/02/2026

## Sectional Diagram showing elements of a typical house

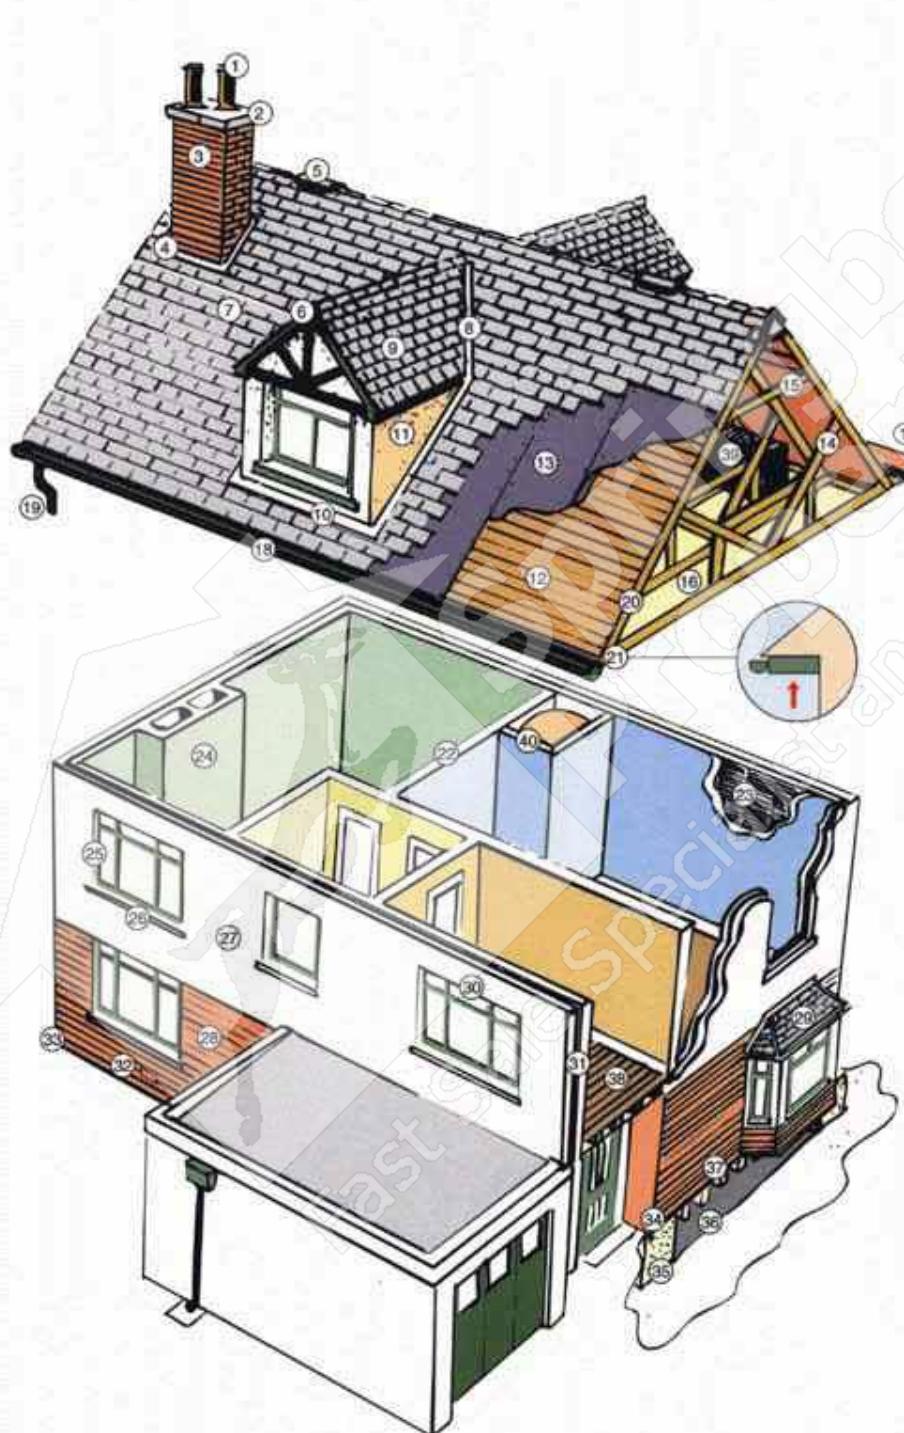
- 1 Chimney pots
- 2 Coping stone
- 3 Chimney head
- 4 Flashing
- 5 Ridge ventilation
- 6 Ridge board
- 7 Slates / tiles
- 8 Valley guttering
- 9 Dormer projection
- 10 Dormer flashing
- 11 Dormer cheeks
- 12 Sarking
- 13 Roof felt
- 14 Trusses
- 15 Collar
- 16 Insulation
- 17 Parapet gutter
- 18 Eaves guttering
- 19 Rainwater downpipe
- 20 Verge boards /skews
- 21 Soffit boards
- 22 Partition wall
- 23 Lath / plaster
- 24 Chimney breast
- 25 Window pointing
- 26 Window sills
- 27 Rendering
- 28 Brickwork / pointing
- 29 Bay window projection
- 30 Lintels
- 31 Cavity walls / wall ties
- 32 Subfloor ventilator
- 33 Damp proof course
- 34 Base course
- 35 Foundations
- 36 Solum
- 37 Floor joists
- 38 Floorboards
- 39 Water tank
- 40 Hot water tank

Reference may be made in this report to some or all of the above component parts of the property. This diagram may assist you in locating and understanding these items.

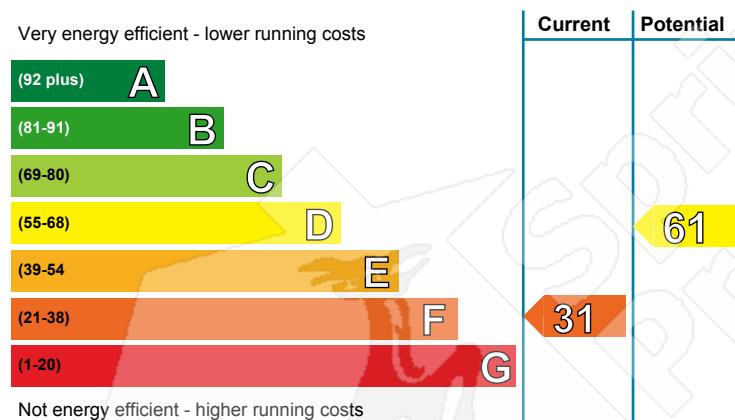
## Energy Efficiency Rating

This graph shows the current efficiency of your home, taking into account both energy efficiency and fuel costs. The higher this rating, the lower your fuel bills are likely to be.

Your current rating is **band F (31)**. The average rating for EPCs in Scotland is **band D (61)**.

The potential rating shows the effect of undertaking all of the improvement measures listed within your recommendations report.

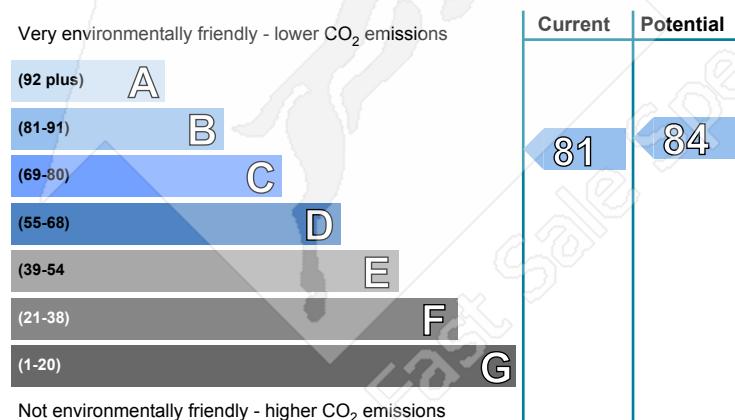
## Environmental Impact (CO<sub>2</sub>) Rating

This graph shows the effect of your home on the environment in terms of carbon dioxide (CO<sub>2</sub>) emissions. The higher the rating, the less impact it has on the environment.
