Home Report

Scottish Single Survey

Single Survey

Property address	22 Broom Crescent Ochiltree Cumnock KA18 2PS
Customer	East Ayrshire Council
Customer address	22 Broom Crescent Ochiltree Cumnock KA18 2PS
Prepared by	Shepherd Chartered Surveyors
Date of inspection	04/06/2026

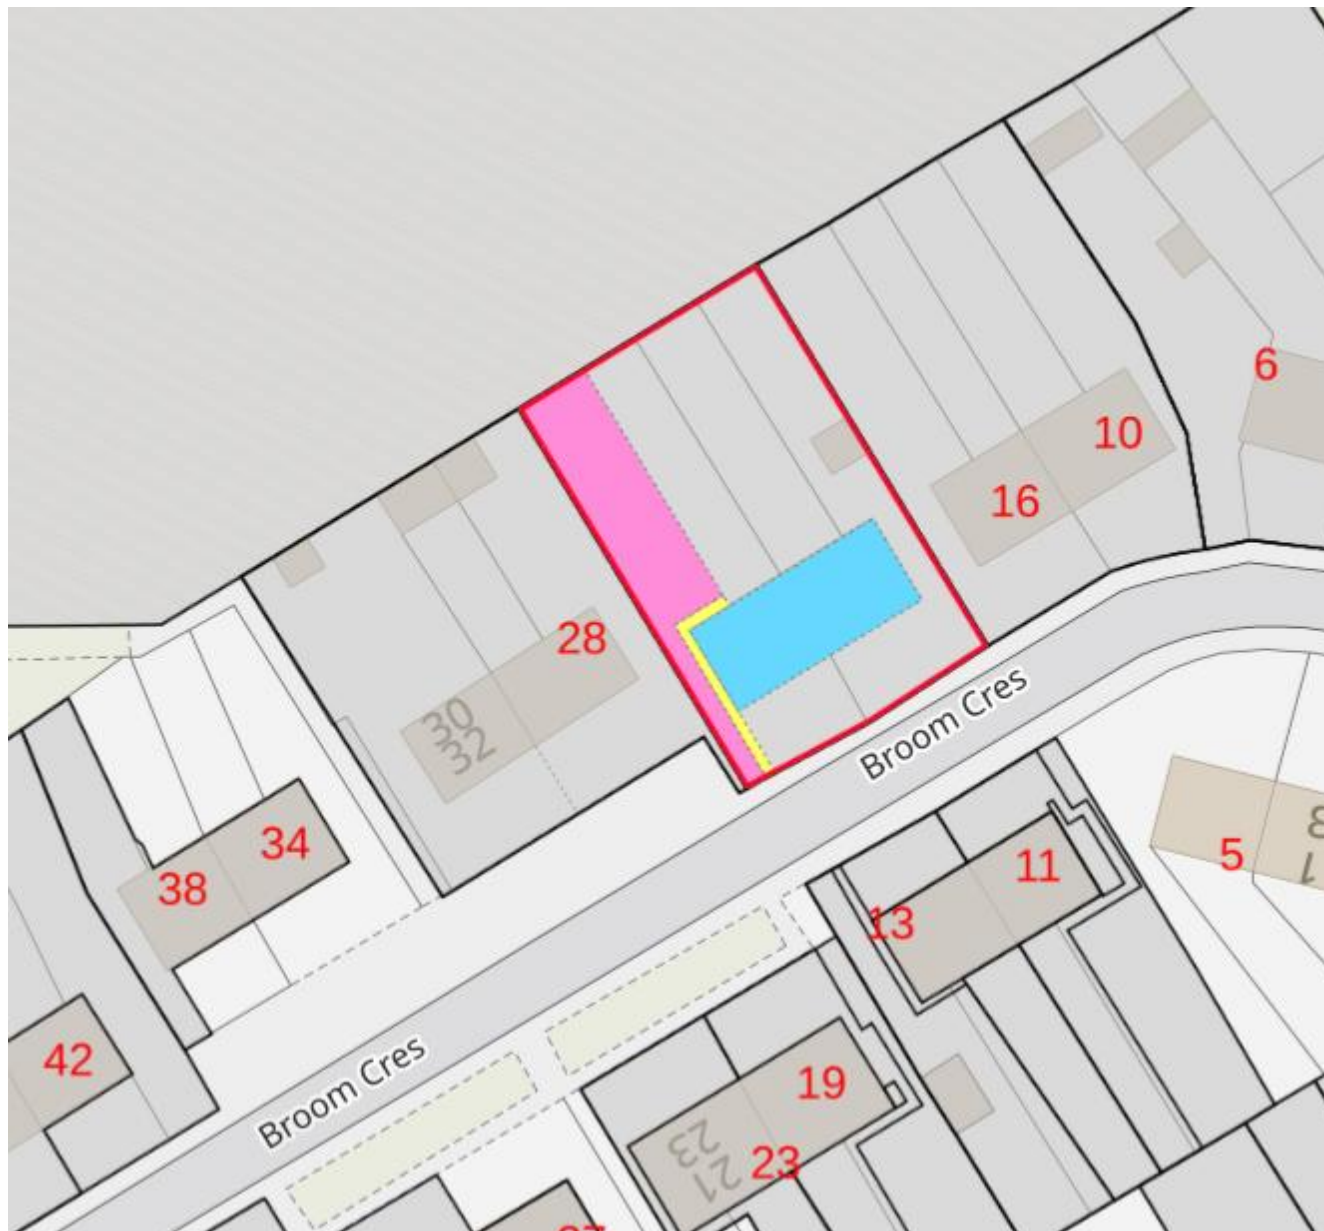
Title plan for No 24 Broom Cres showing block 18-24 in blue, garden of No 24 in pink and shared common access path with Nos 22 & 24 shown in yellow
