2 Steading Cottage,
Haugh of Urr,
Castle Douglas,
Kirkcudbrightshire,
DG7 3LB

Home Report

Single Survey

Property Address	2 Steading Cottage, Haugh of Urr, Castle Douglas, Kirkcudbrightshire, DG7 3LB
Reference	1190628
Customer Name	Kirstine & Scott Hale
Date of Inspection	25th August 2025
Surveyor's name, qualifications and office	Michael P Churm BSc (Hon's) MRICS DM Hall LLP Chartered Surveyors 11 Buccleuch Street Dumfries DG1 2AT Tel: 01387 254318 email: dumfriesresidential@dmhall.co.uk
Prepared By	DM Hall LLP

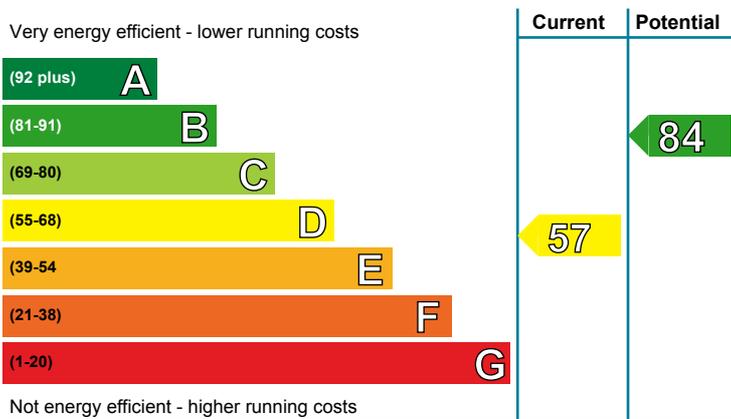
Energy Efficiency Rating

This graph shows the current efficiency of your home, taking into account both energy efficiency and fuel costs. The higher this rating, the lower your fuel bills are likely to be.

Your current rating is **band D (57)**. The average rating for EPCs in Scotland is **band D (61)**.

The potential rating shows the effect of undertaking all of the improvement measures listed within your recommendations report.

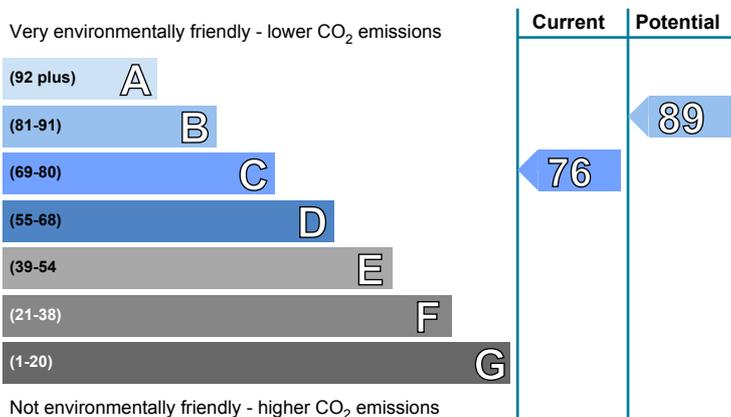
Environmental Impact (CO₂) Rating

This graph shows the effect of your home on the environment in terms of carbon dioxide (CO₂) emissions. The higher the rating, the less impact it has on the environment.
