Single Survey

survey report on:

Property address	Four Oaks, Alford, AB33 8NB
-------------------------	-----------------------------------

Prepared by	Allied Surveyors Scotland Ltd
--------------------	-------------------------------

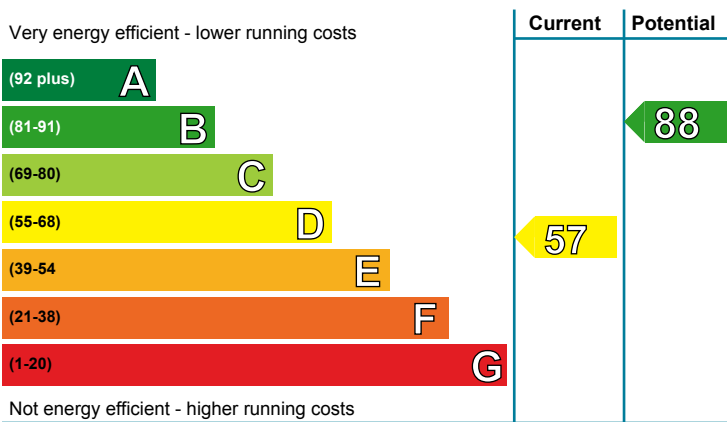
Energy Efficiency Rating

This graph shows the current efficiency of your home, taking into account both energy efficiency and fuel costs. The higher this rating, the lower your fuel bills are likely to be.

Your current rating is **band D (57)**. The average rating for EPCs in Scotland is **band D (61)**.

The potential rating shows the effect of undertaking all of the improvement measures listed within your recommendations report.

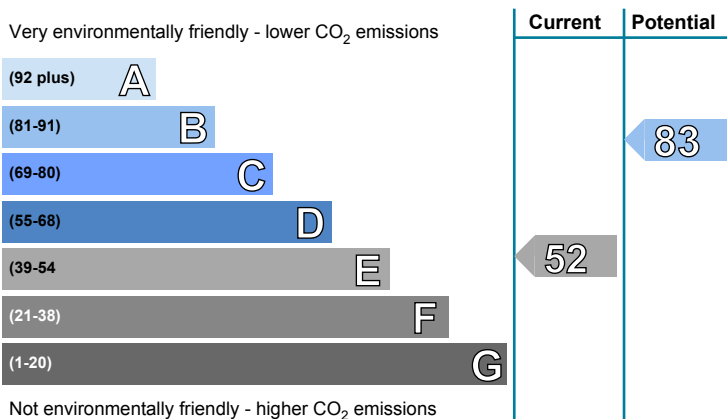
Environmental Impact (CO₂) Rating

This graph shows the effect of your home on the environment in terms of carbon dioxide (CO₂) emissions. The higher the rating, the less impact it has on the environment.
