Home Report

Scottish Single Survey

Single Survey

Property address	1/R 9 James Street Dalry KA24 5ET
-------------------------	--

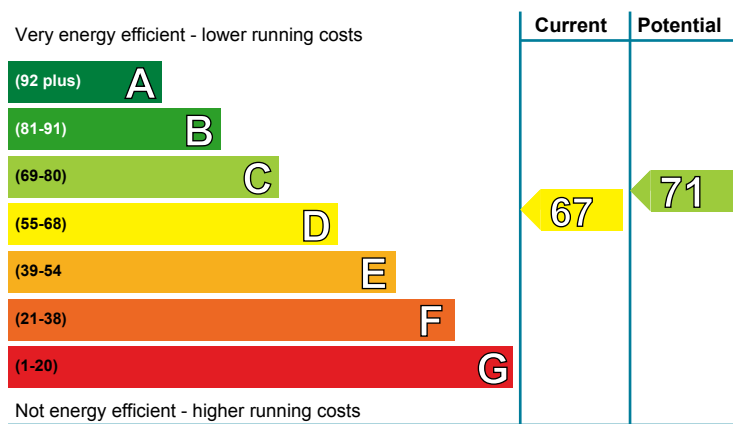
Energy Efficiency Rating

This graph shows the current efficiency of your home, taking into account both energy efficiency and fuel costs. The higher this rating, the lower your fuel bills are likely to be.

Your current rating is **band D (67)**. The average rating for EPCs in Scotland is **band D (61)**.

The potential rating shows the effect of undertaking all of the improvement measures listed within your recommendations report.
