HOME
report

SINGLE SURVEY
ENERGY REPORT
PROPERTY QUESTIONNAIRE
VALUATION REPORT

Single Survey

Property Address	3 Wade Road, Inverness, IV2 3DG
Customer	Nina St Charles Ltd & Ms J Holland
Date of Inspection	17/02/2026
Prepared by	Douglas J H Mowat Harvey Donaldson & Gibson Chartered Surveyors

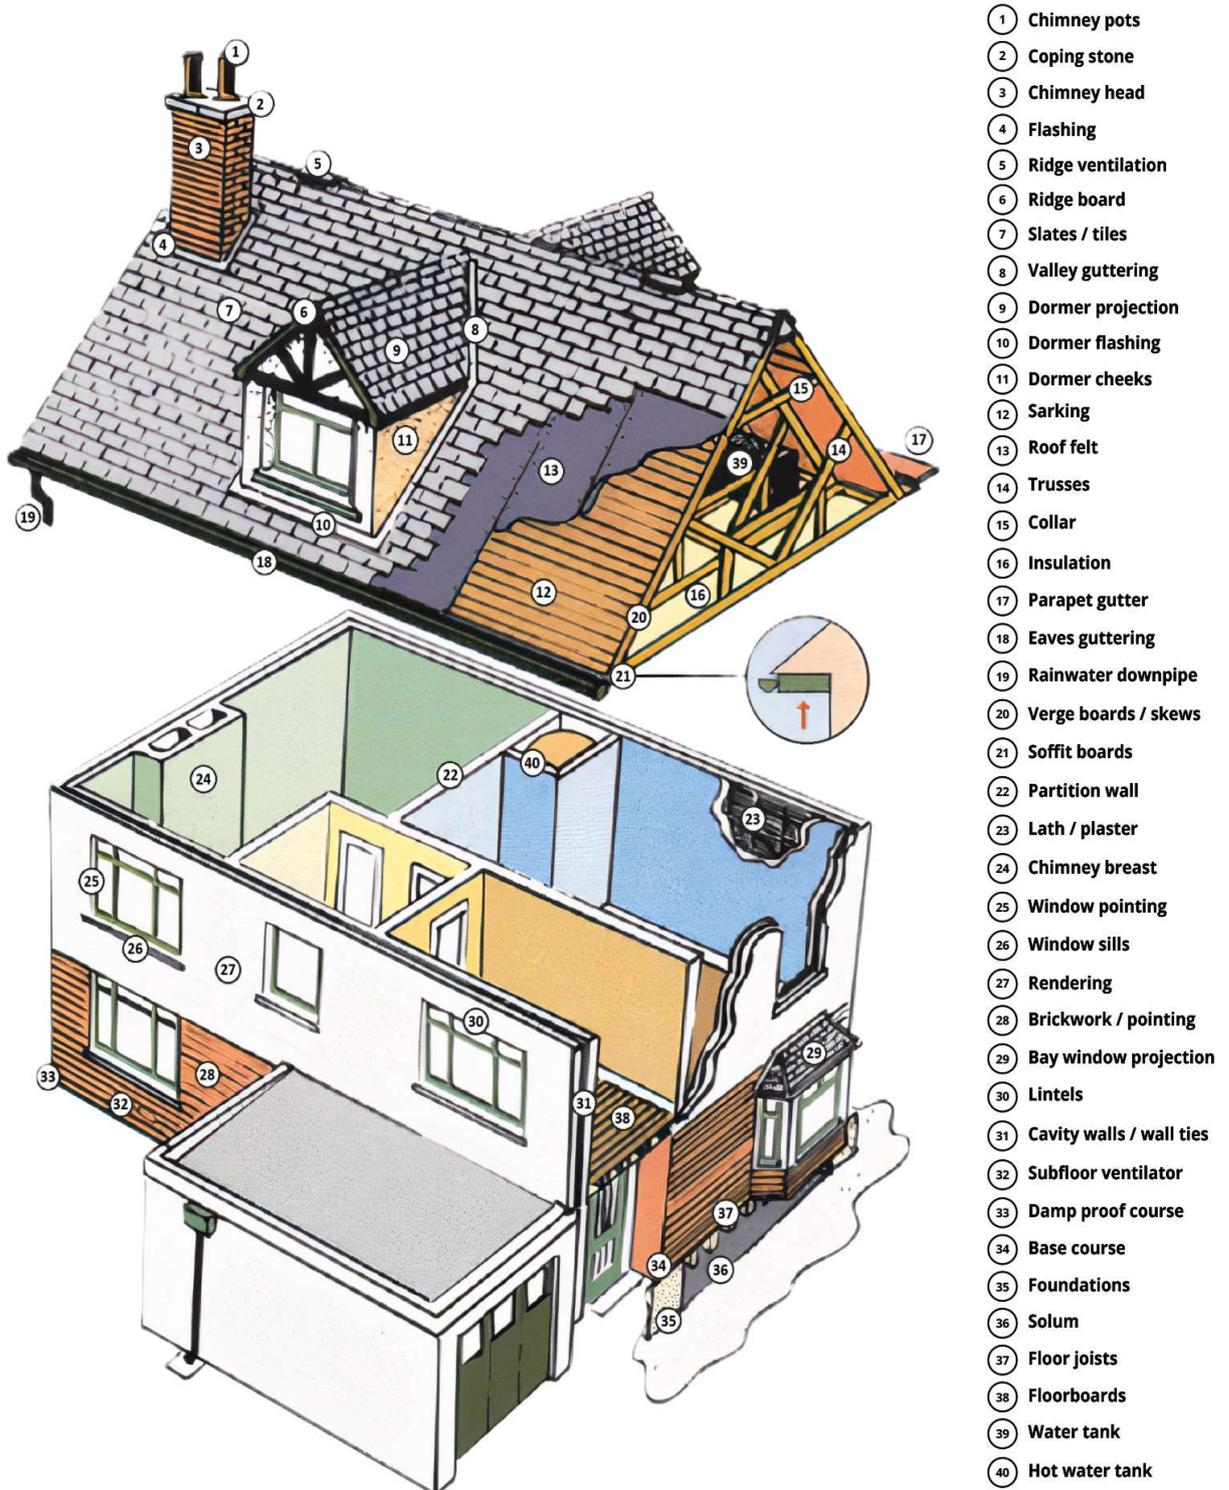
Sectional Diagram showing elements of a typical house

Reference may be made in this report to some or all of the above component parts of the property. This diagram may assist you in locating and understanding these items.

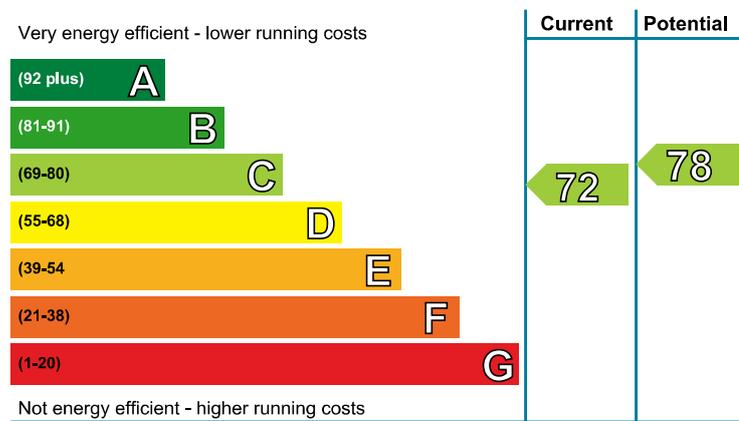
Energy Efficiency Rating

This graph shows the current efficiency of your home, taking into account both energy efficiency and fuel costs. The higher this rating, the lower your fuel bills are likely to be.

Your current rating is **band C (72)**. The average rating for EPCs in Scotland is **band D (61)**.

The potential rating shows the effect of undertaking all of the improvement measures listed within your recommendations report.

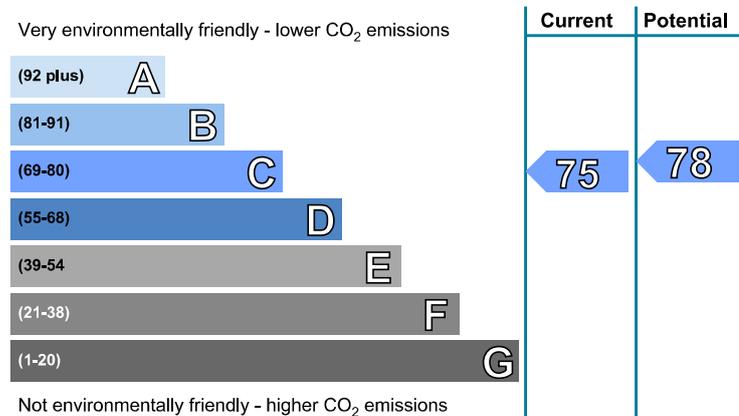
Environmental Impact (CO₂) Rating

This graph shows the effect of your home on the environment in terms of carbon dioxide (CO₂) emissions. The higher the rating, the less impact it has on the environment.
