Home Report

Scottish Single Survey

Single Survey

Property address	2/2 6 Rutland Court Glasgow G51 1JZ
Customer	JACQUELINE & JOHN HOPKINS
Customer address	2/2 6 Rutland Court Glasgow G51 1JZ
Prepared by	Shepherd Chartered Surveyors
Date of inspection	22/06/2026

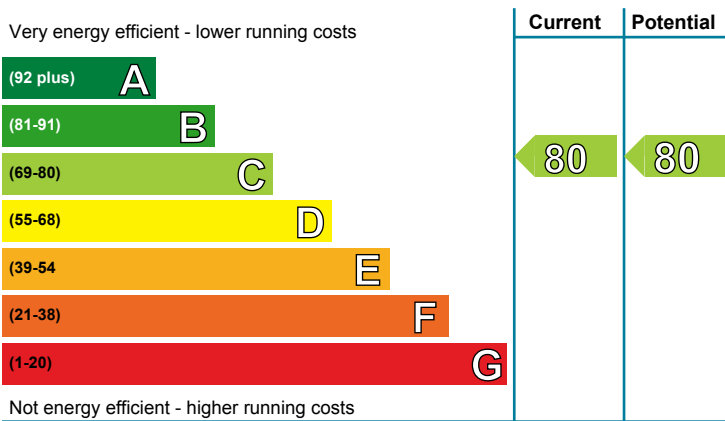
Energy Efficiency Rating

This graph shows the current efficiency of your home, taking into account both energy efficiency and fuel costs. The higher this rating, the lower your fuel bills are likely to be.

Your current rating is **band C (80)**. The average rating for EPCs in Scotland is **band D (61)**.

The potential rating shows the effect of undertaking all of the improvement measures listed within your recommendations report.

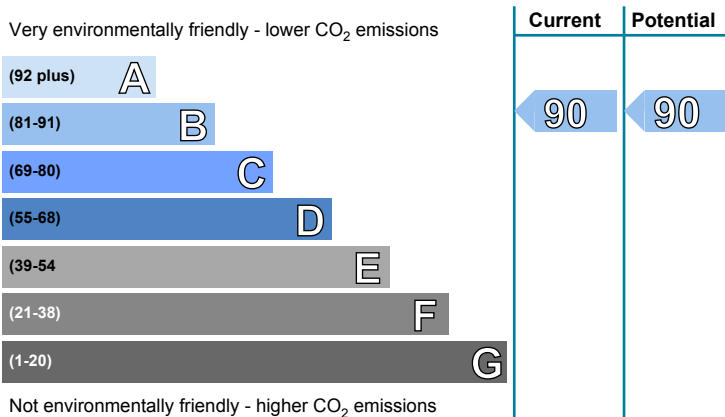
Environmental Impact (CO₂) Rating

This graph shows the effect of your home on the environment in terms of carbon dioxide (CO₂) emissions. The higher the rating, the less impact it has on the environment.
