Home Report

42 Frithside Street
Fraserburgh
AB43 9AR

Energy Performance Certificate (EPC)

Dwelling type: Top-floor maisonette
Date of assessment: 26 November 2025
Date of certificate: 03 December 2025
Total floor area: 95 m²
Primary Energy Indicator: 273 kWh/m²/year

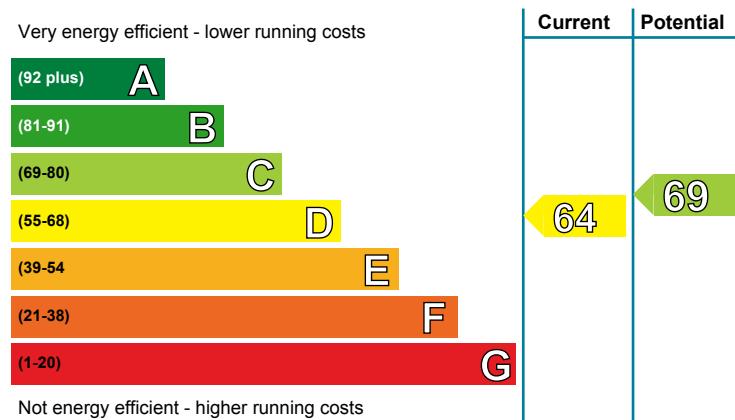
Energy Efficiency Rating

This graph shows the current efficiency of your home, taking into account both energy efficiency and fuel costs. The higher this rating, the lower your fuel bills are likely to be.

Your current rating is **band D (64)**. The average rating for EPCs in Scotland is **band D (61)**.

The potential rating shows the effect of undertaking all of the improvement measures listed within your recommendations report.

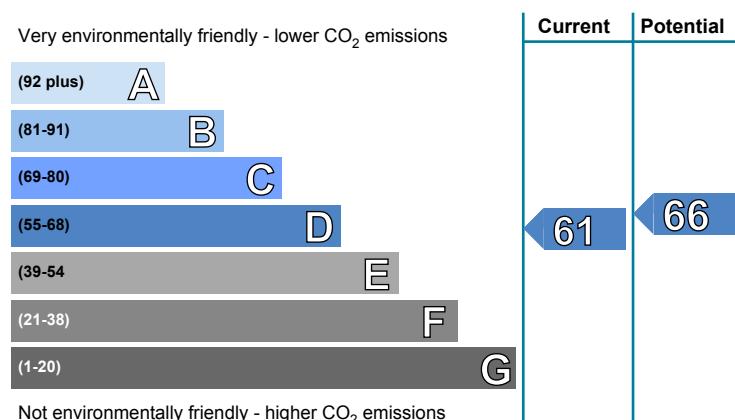
Environmental Impact (CO₂) Rating

This graph shows the effect of your home on the environment in terms of carbon dioxide (CO₂) emissions. The higher the rating, the less impact it has on the environment.

Your current rating is **band D (61)**

The potential rating shows the effect of undertaking all of the improvement measures listed within your recommendations report.
