Home Report

2 Barnchalloch Cottages
Stranraer DG9 9BP

Single Survey

Property Address	2 Barnchalloch Cottages Stranraer DG9 9BP
Customer	Lorraine and John Watson
Prepared by	Graham + Sibbald Property Consultants Limited
Date of Inspection	22/01/2026

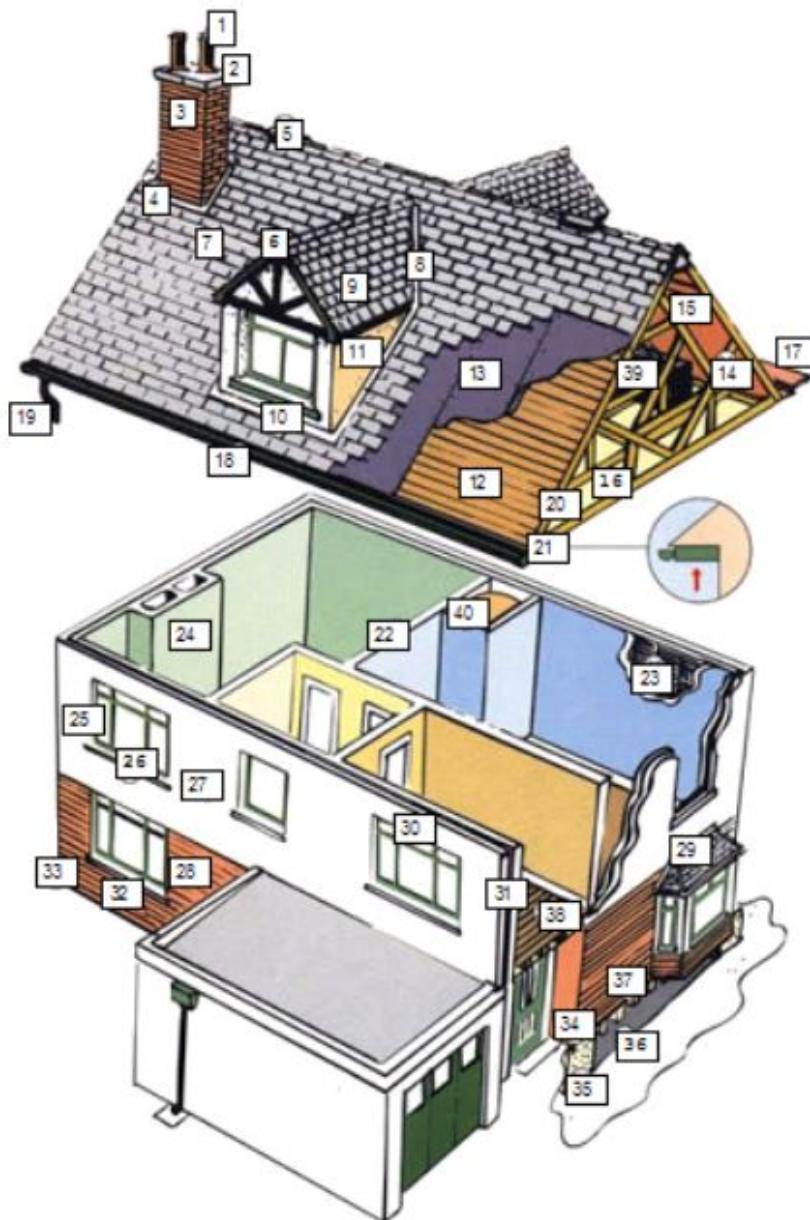
Sectional diagram showing elements of a typical house

1	Chimney pots
2	Coping stone
3	Chimney head
4	Flashing
5	Ridge ventilation
6	Ridge board
7	Slates / tiles
8	Valley guttering
9	Dormer projection
10	Dormer flashing
11	Dormer cheeks
12	Sarking
13	Roof felt
14	Trusses
15	Collar
16	Insulation
17	Parapet gutter
18	Eaves guttering
19	Rainwater downpipe
20	Verge boards / skews
21	Soffit boards
22	Partition wall
23	Lath / plaster
24	Chimney breast
25	Window pointing
26	Window sills
27	Rendering
28	Brickwork / pointing
29	Bay window projection
30	Lintels
31	Cavity walls / wall ties
32	Subfloor ventilator
33	Damp proof course
34	Base course
35	Foundations
36	Solum
37	Floor joists
38	Floorboards
39	Water tank
40	Hot water tank

Reference may be made in this report to some or all of the above component parts of the property. This diagram may assist you in locating and understanding these items.
