6 Ochilview,  
Ashfield,  
Dunblane,  
FK15 0JW

# Home Report

# Single Survey

## Survey Report on:

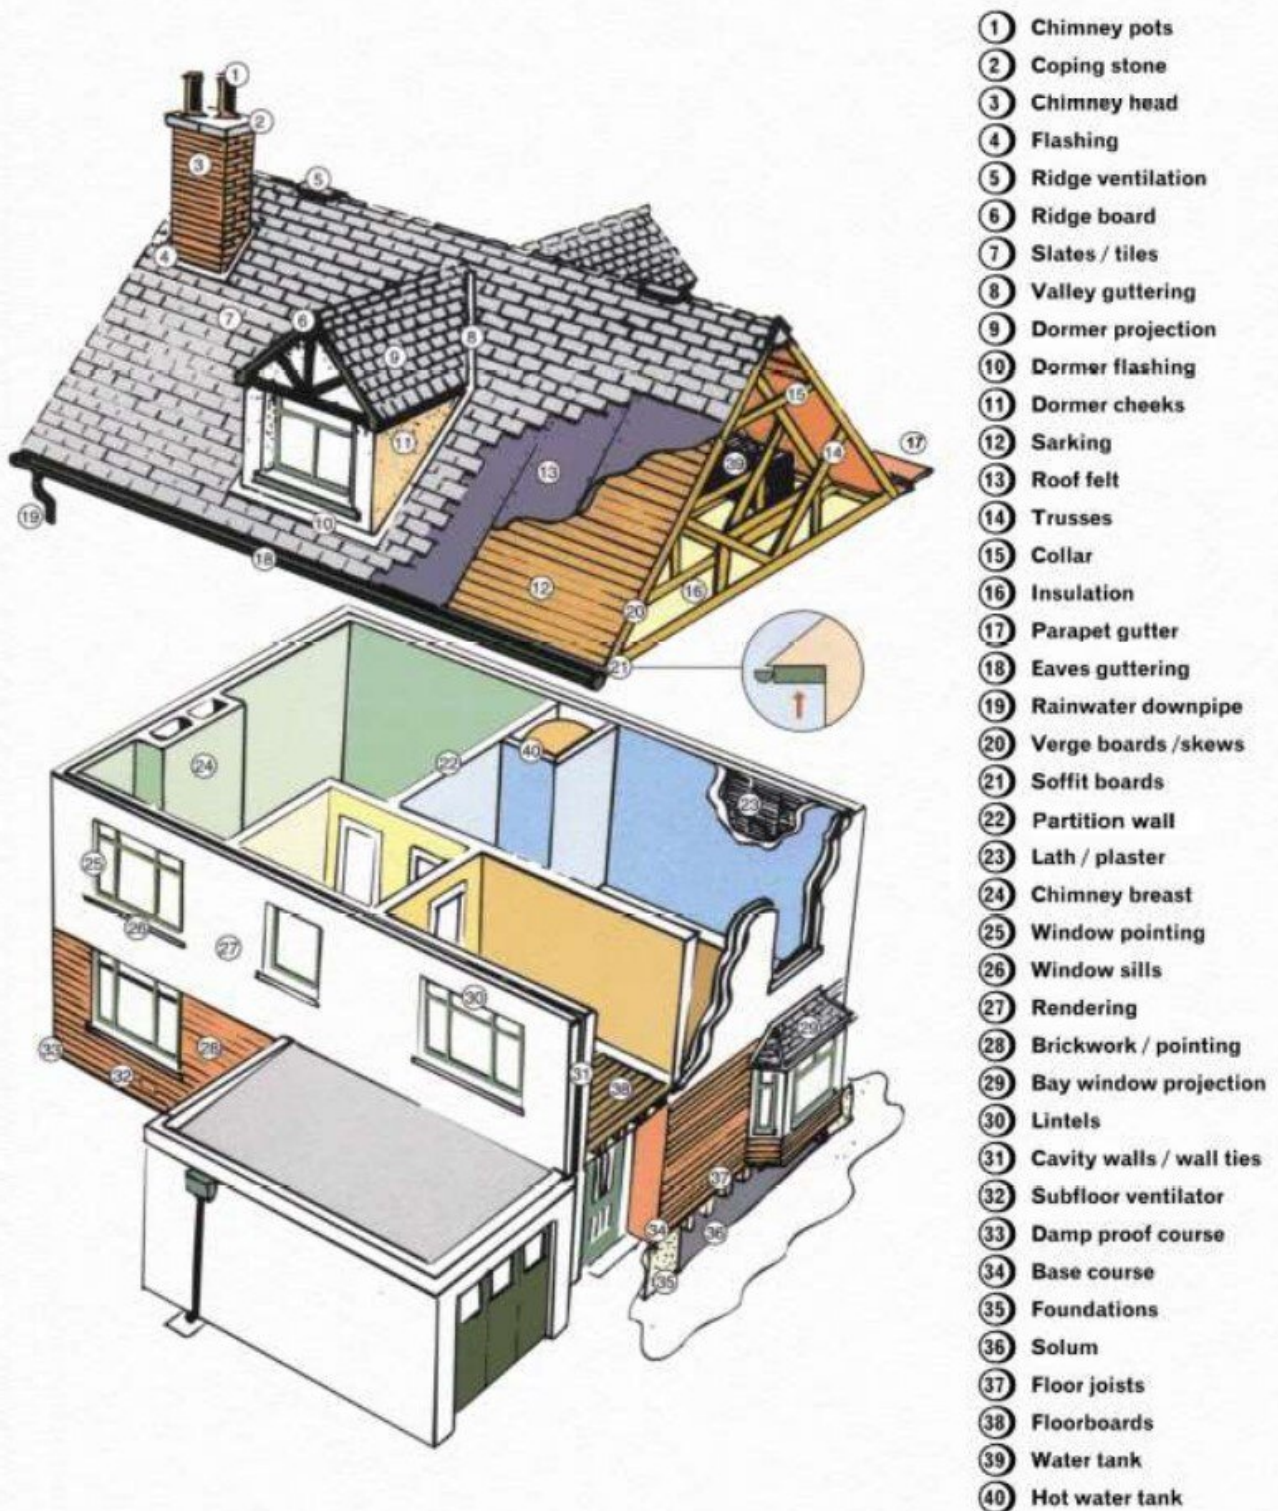
## Sectional Diagram showing elements of a typical house

Reference may be made in this report to some or all of the above component parts of the property. This diagram may assist you in locating and understanding these items.
