# Home Report

# Scottish Single Survey

<b>Property address</b>	12/4 101 Maxwell Street Glasgow G1 4EP
<b>Customer</b>	Mr G Houston
<b>Customer address</b>	12/4 101 Maxwell Street Glasgow G1 4EP
<b>Prepared by</b>	Shepherd Chartered Surveyors
<b>Date of inspection</b>	28/01/2026

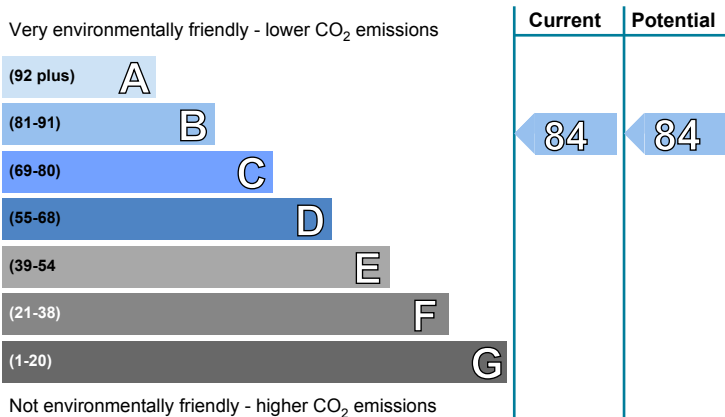
## Environmental Impact (CO<sub>2</sub>) Rating

This graph shows the effect of your home on the environment in terms of carbon dioxide (CO<sub>2</sub>) emissions. The higher the rating, the less impact it has on the environment.
