# Home Report

# Scottish Single Survey

<b>Property address</b>	216 Haymarket Street Glasgow G32 6QZ
<b>Customer</b>	[REDACTED]
<b>Customer address</b>	216 Haymarket Street Glasgow G32 6QZ
<b>Prepared by</b>	Shepherd Chartered Surveyors
<b>Date of inspection</b>	24/04/2026

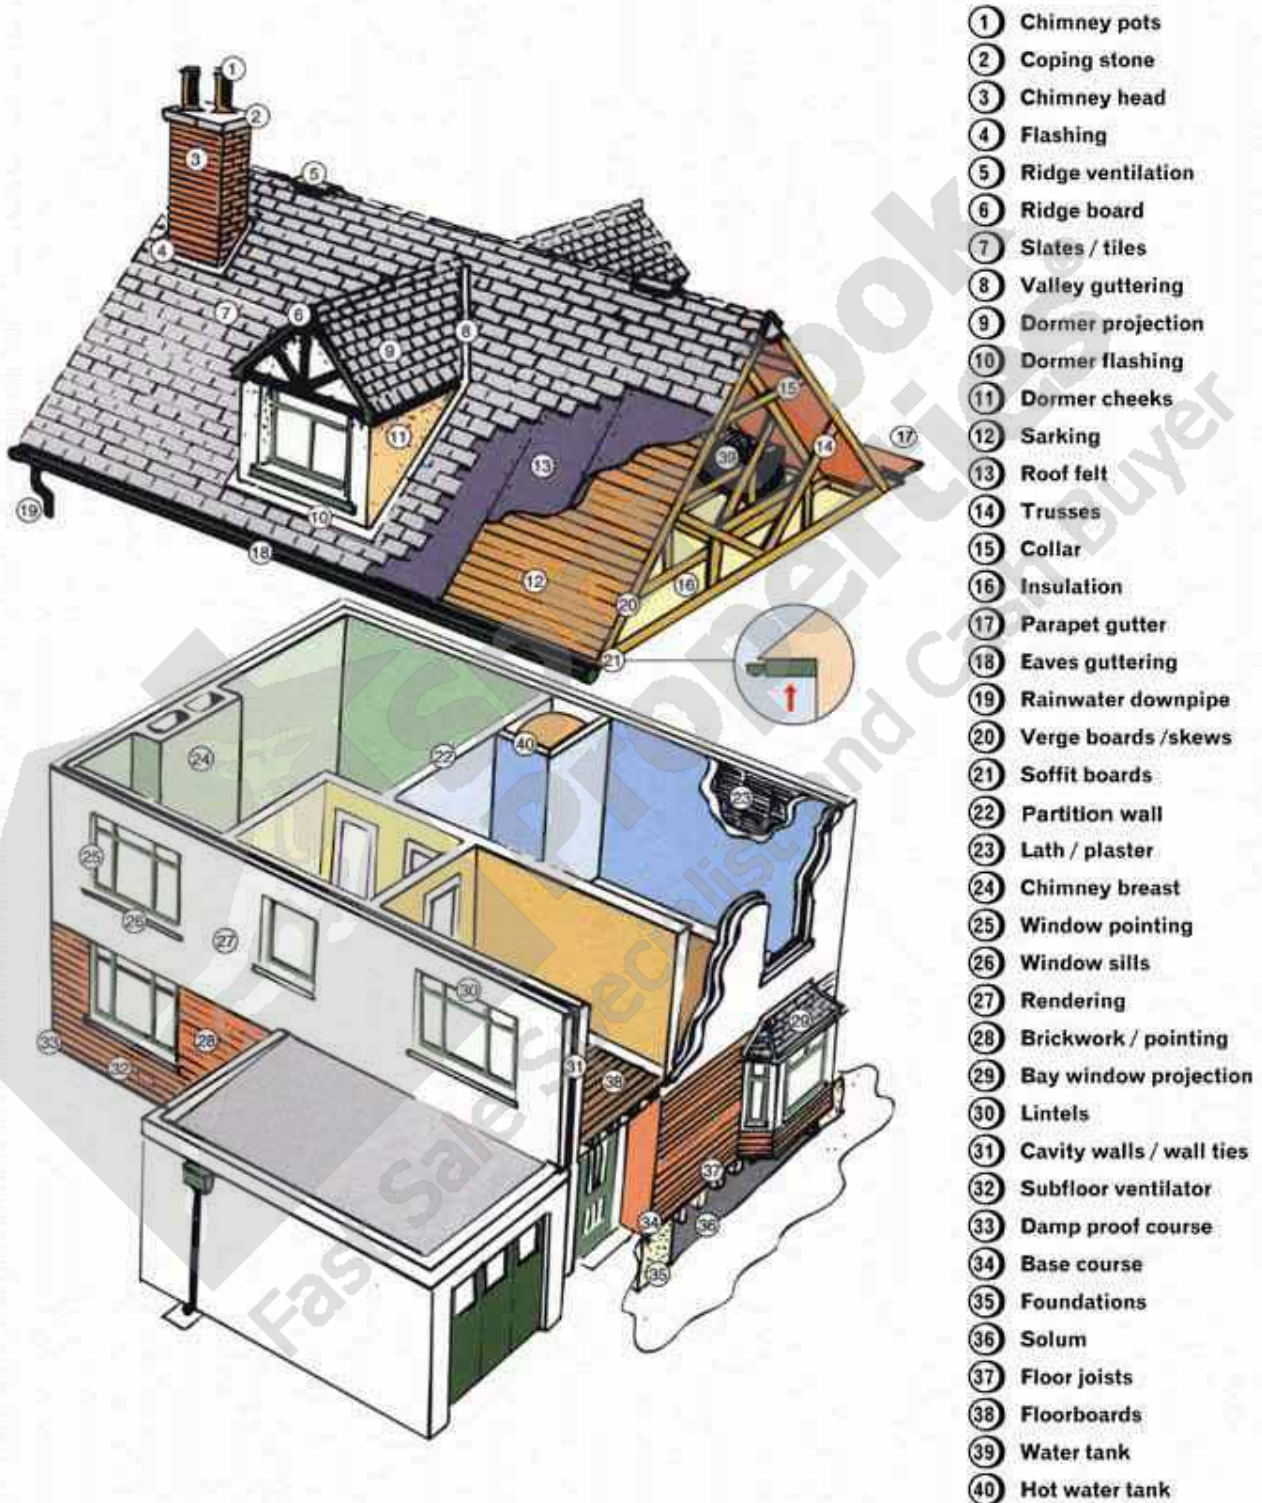
## Sectional Diagram showing elements of a typical house

Reference may be made in this report to some or all of the above component parts of the property. This diagram may assist you in locating and understanding these items.
