Mill Of Crichtie,  
Mill Street,  
Stuartfield,  
Peterhead,  
AB42 5DP

# Home Report

# Single Survey

## Survey Report on:

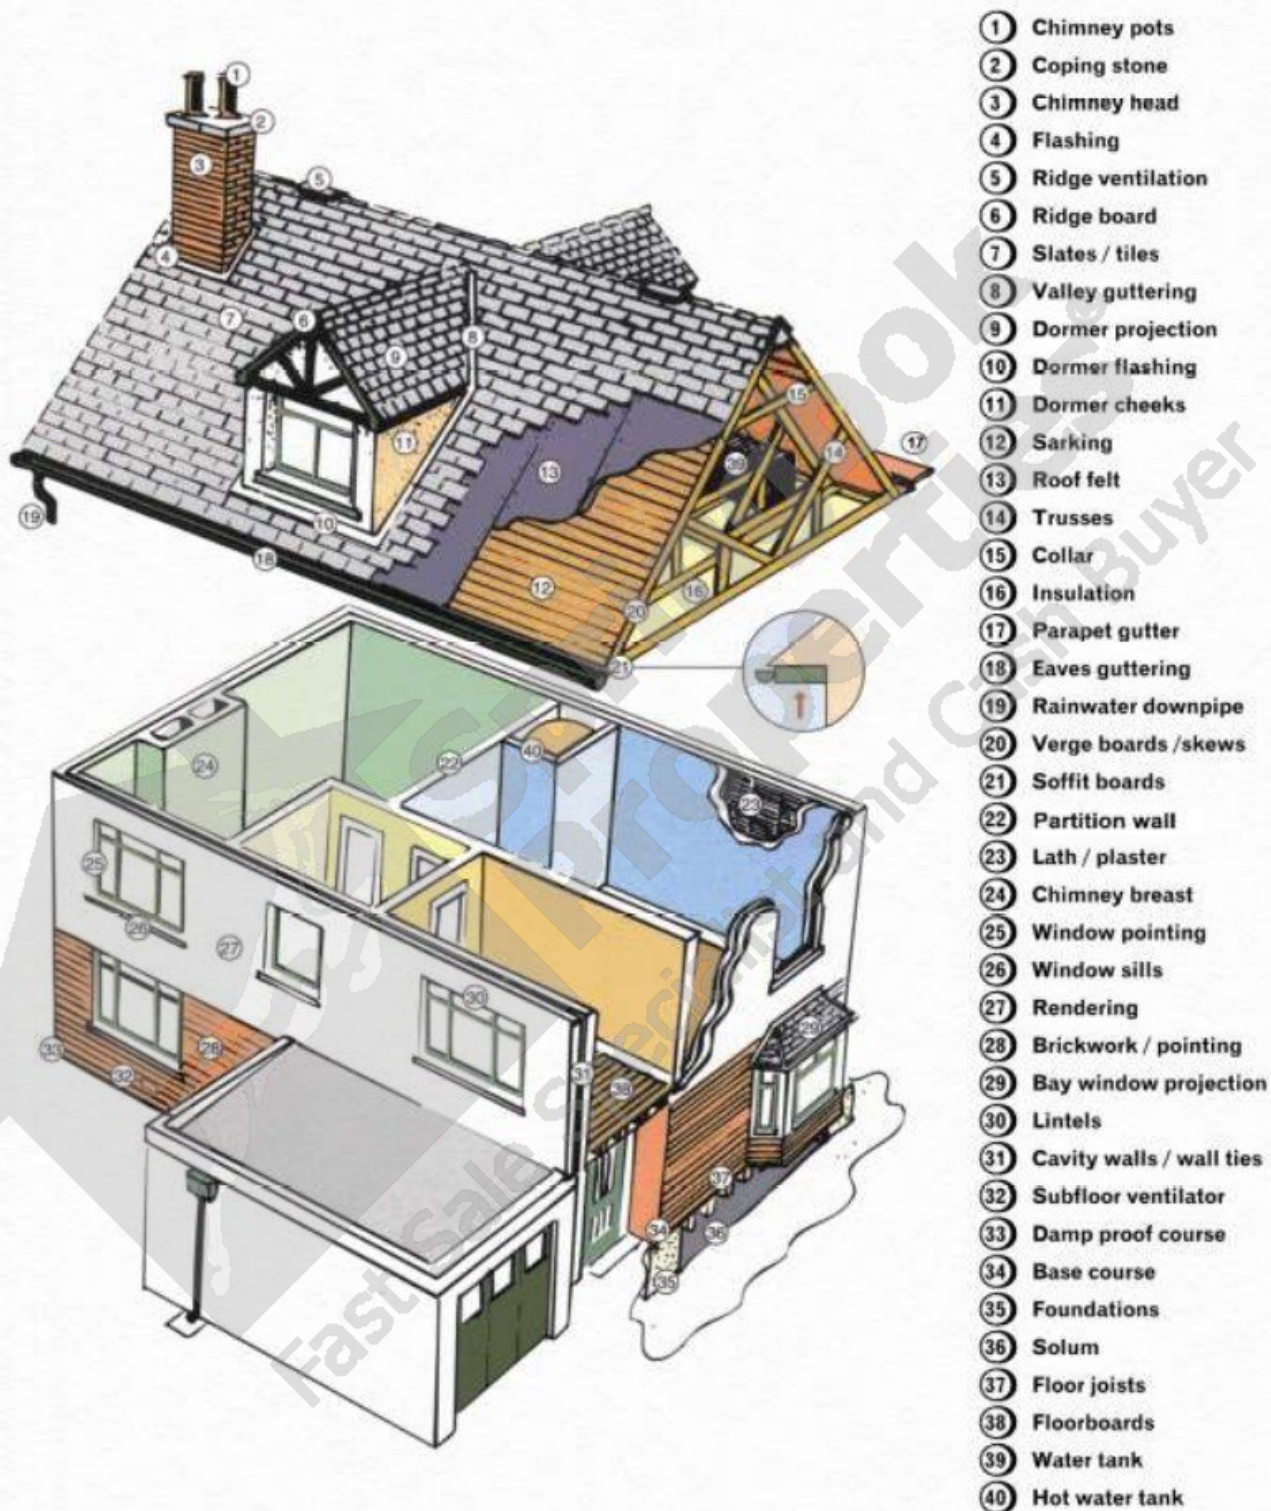
## Sectional Diagram showing elements of a typical house

Reference may be made in this report to some or all of the above component parts of the property. This diagram may assist you in locating and understanding these items.
