Single Survey

survey report on:

Property address	South Farden Croft, Newburgh, Ellon, AB41 6AJ
-------------------------	--

Prepared by	Allied Surveyors Scotland Ltd
--------------------	-------------------------------

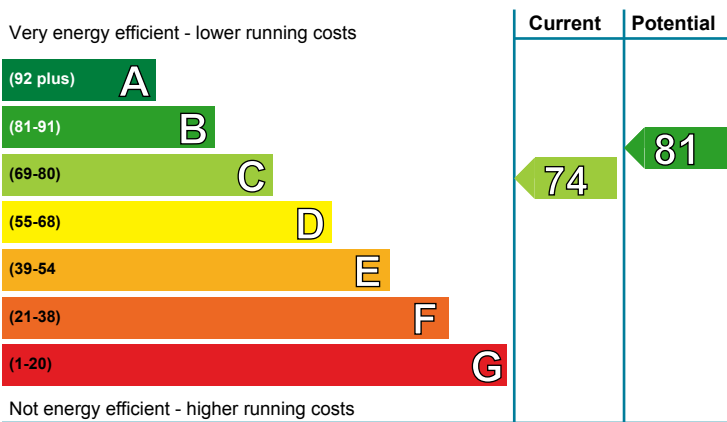
Energy Efficiency Rating

This graph shows the current efficiency of your home, taking into account both energy efficiency and fuel costs. The higher this rating, the lower your fuel bills are likely to be.

Your current rating is **band C (74)**. The average rating for EPCs in Scotland is **band D (61)**.

The potential rating shows the effect of undertaking all of the improvement measures listed within your recommendations report.

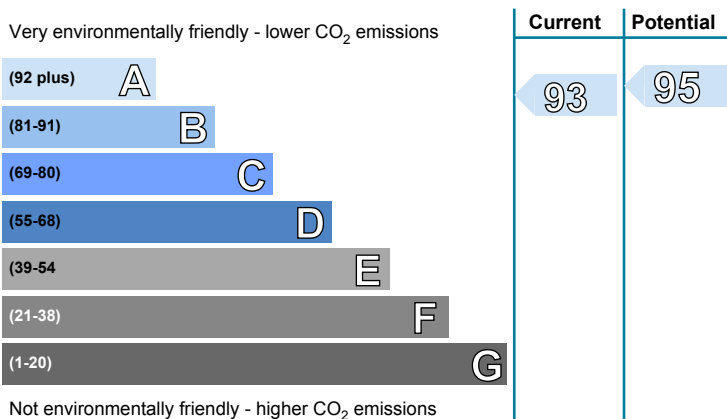
Environmental Impact (CO₂) Rating

This graph shows the effect of your home on the environment in terms of carbon dioxide (CO₂) emissions. The higher the rating, the less impact it has on the environment.
