YOUR ONESURVEY  
**HOME REPORT**

3/1  
9 Clarence Drive  
Glasgow  
G12 9QL

# SINGLE SURVEY

# Single Survey

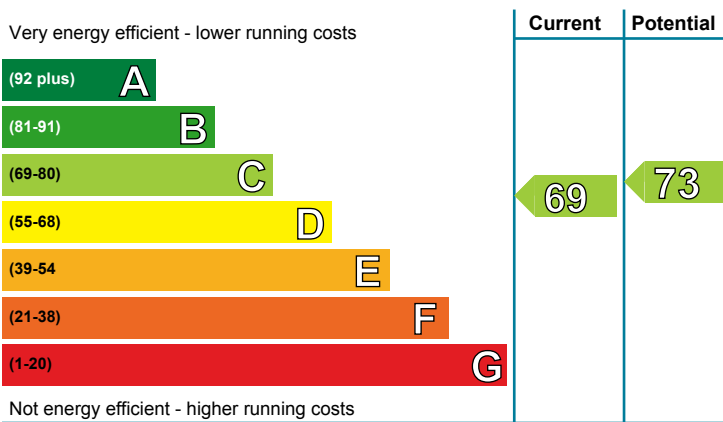
## Energy Efficiency Rating

This graph shows the current efficiency of your home, taking into account both energy efficiency and fuel costs. The higher this rating, the lower your fuel bills are likely to be.

Your current rating is **band C (69)**. The average rating for EPCs in Scotland is **band D (61)**.

The potential rating shows the effect of undertaking all of the improvement measures listed within your recommendations report.

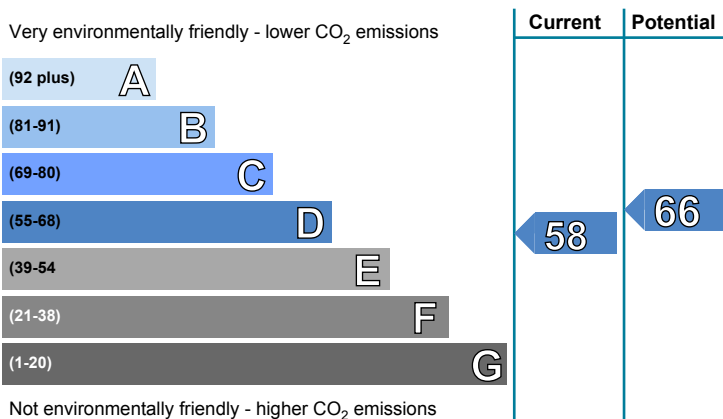
## Environmental Impact (CO<sub>2</sub>) Rating

This graph shows the effect of your home on the environment in terms of carbon dioxide (CO<sub>2</sub>) emissions. The higher the rating, the less impact it has on the environment.
