Home Report

29 Kennedy Drive,
Airdrie,
Lanarkshire,
ML6 9AW

Single Survey

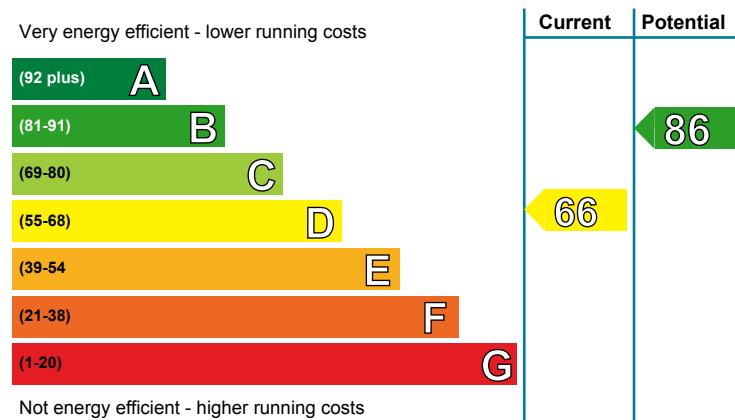
Energy Efficiency Rating

This graph shows the current efficiency of your home, taking into account both energy efficiency and fuel costs. The higher this rating, the lower your fuel bills are likely to be.

Your current rating is **band D (66)**. The average rating for EPCs in Scotland is **band D (61)**.

The potential rating shows the effect of undertaking all of the improvement measures listed within your recommendations report.

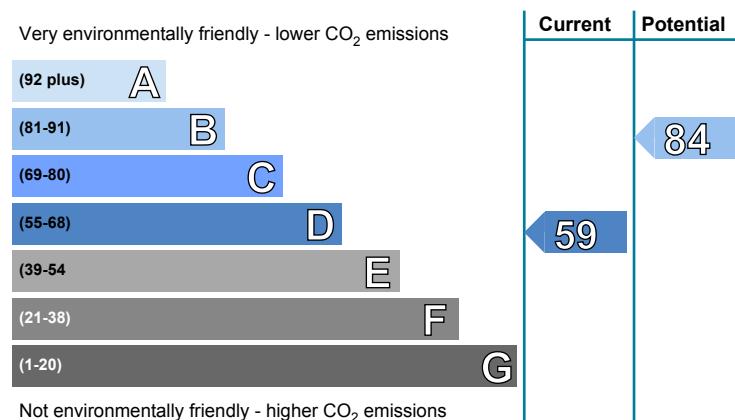
Environmental Impact (CO₂) Rating

This graph shows the effect of your home on the environment in terms of carbon dioxide (CO₂) emissions. The higher the rating, the less impact it has on the environment.
