YOUR ONESURVEY  
**HOME REPORT**

1/2  
11 Victoria Park Drive South  
Glasgow  
G14 9RN

# SINGLE SURVEY

# Single Survey

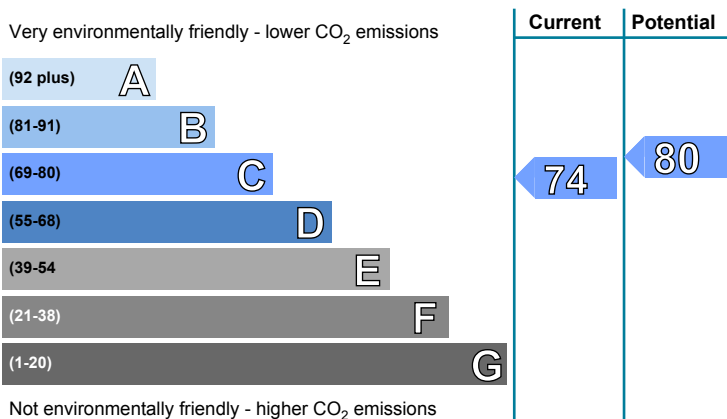
## Environmental Impact (CO<sub>2</sub>) Rating

This graph shows the effect of your home on the environment in terms of carbon dioxide (CO<sub>2</sub>) emissions. The higher the rating, the less impact it has on the environment.
