YOUR ONESURVEY  
**HOME REPORT**

Flat 215/3  
Great Junction Street  
Edinburgh  
EH6 5RU

# SINGLE SURVEY

# Single Survey

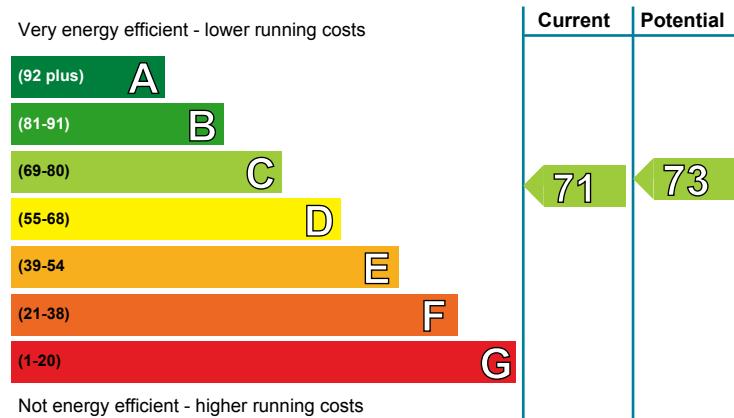
## Energy Efficiency Rating

This graph shows the current efficiency of your home, taking into account both energy efficiency and fuel costs. The higher this rating, the lower your fuel bills are likely to be.

Your current rating is **band C (71)**. The average rating for EPCs in Scotland is **band D (61)**.

The potential rating shows the effect of undertaking all of the improvement measures listed within your recommendations report.

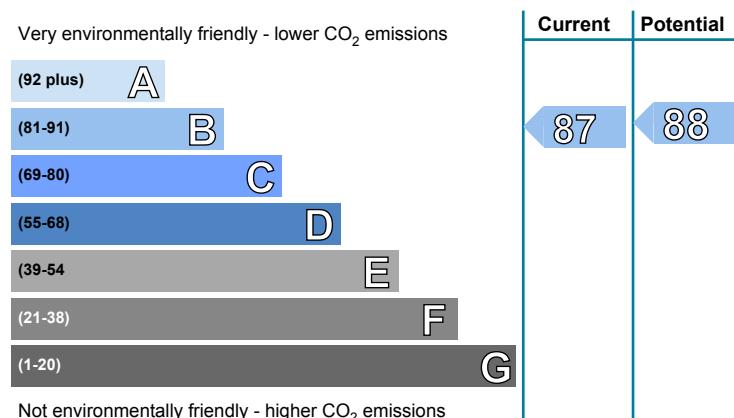
## Environmental Impact (CO<sub>2</sub>) Rating

This graph shows the effect of your home on the environment in terms of carbon dioxide (CO<sub>2</sub>) emissions. The higher the rating, the less impact it has on the environment.
