Home Report

Single Survey

Property address	0/2 16 Kilnside Road Paisley PA1 1SJ
Customer	Jagit Singh Purba
Customer address	0/2 16 Kilnside Road Paisley PA1 1SJ
Prepared by	Shepherd Chartered Surveyors
Date of inspection	20/01/2026

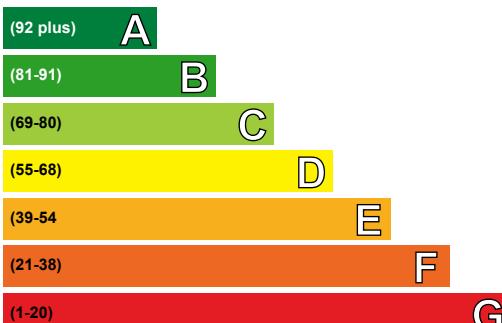
Energy Efficiency Rating

* based upon the cost of energy for heating, hot water, lighting and ventilation, calculated using standard assumptions

Very energy efficient - lower running costs

Not energy efficient - higher running costs

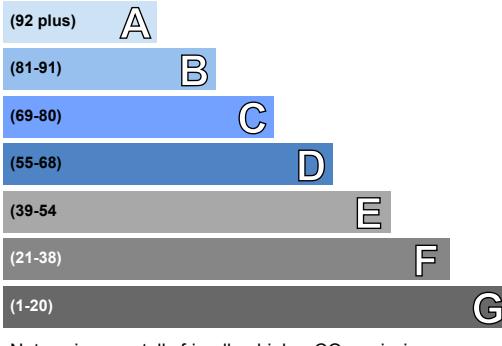
Environmental Impact (CO₂) Rating

Very environmentally friendly - lower CO₂ emissions
