Home Report

5 Glen Road
Shotts ML7 5EA

Single Survey

Property Address	5 Glen Road Shotts ML7 5EA
Customer	Steven White
Prepared by	Graham + Sibbald Property Consultants Limited
Date of Inspection	10/06/2026

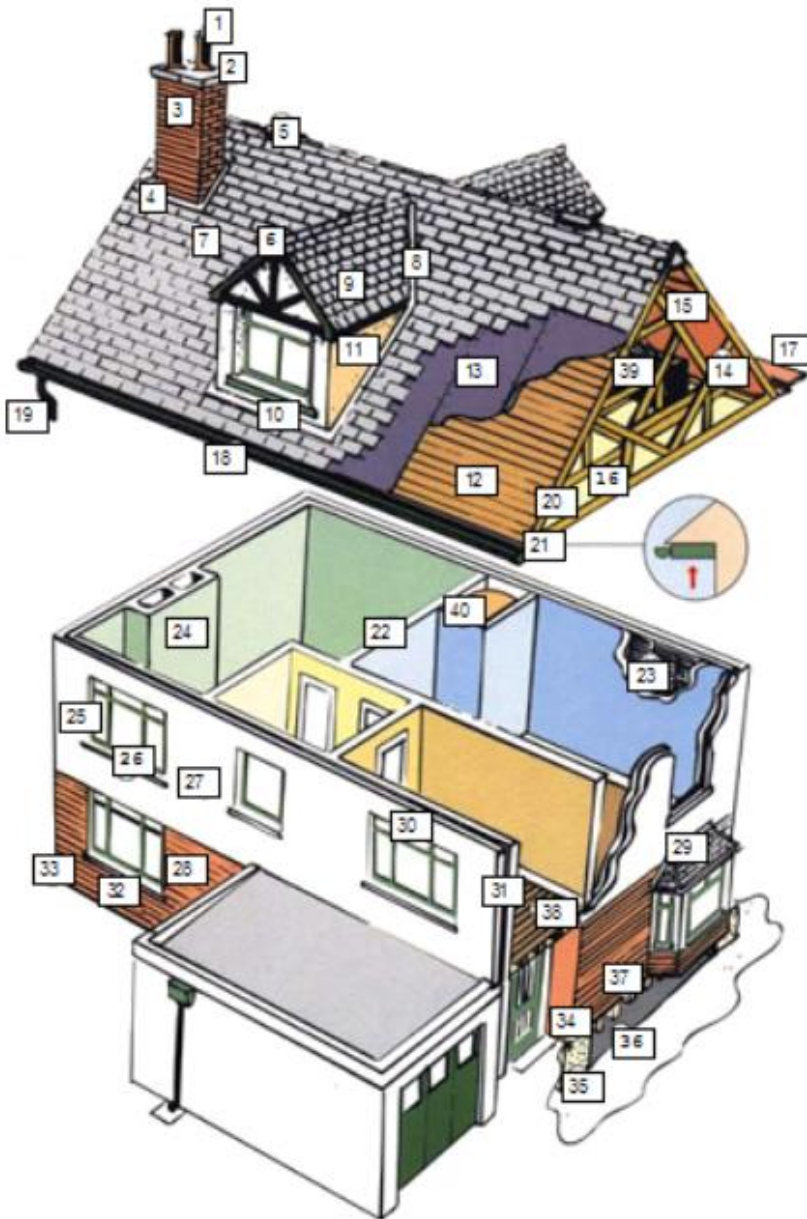
Sectional diagram showing elements of a typical house

1	Chimney pots
2	Coping stone
3	Chimney head
4	Flashing
5	Ridge ventilation
6	Ridge board
7	Slates / tiles
8	Valley guttering
9	Dormer projection
10	Dormer flashing
11	Dormer cheeks
12	Sarking
13	Roof felt
14	Trusses
15	Collar
16	Insulation
17	Parapet gutter
18	Eaves guttering
19	Rainwater downpipe
20	Verge boards / skewes
21	Soffit boards
22	Partition wall
23	Lath / plaster
24	Chimney breast
25	Window pointing
26	Window sills
27	Rendering
28	Brickwork / pointing
29	Bay window projection
30	Lintels
31	Cavity walls / wall ties
32	Subfloor ventilator
33	Damp proof course
34	Base course
35	Foundations
36	Solum
37	Floor joists
38	Floorboards
39	Water tank
40	Hot water tank

Reference may be made in this report to some or all of the above component parts of the property. This diagram may assist you in locating and understanding these items.
