Single Survey

Survey Report on: 4 Linga, Wethersta, Brae, Shetland, ZE2 9QL

Date of inspection: 02 October 2025

Prepared by: Shetland Surveyors Ltd

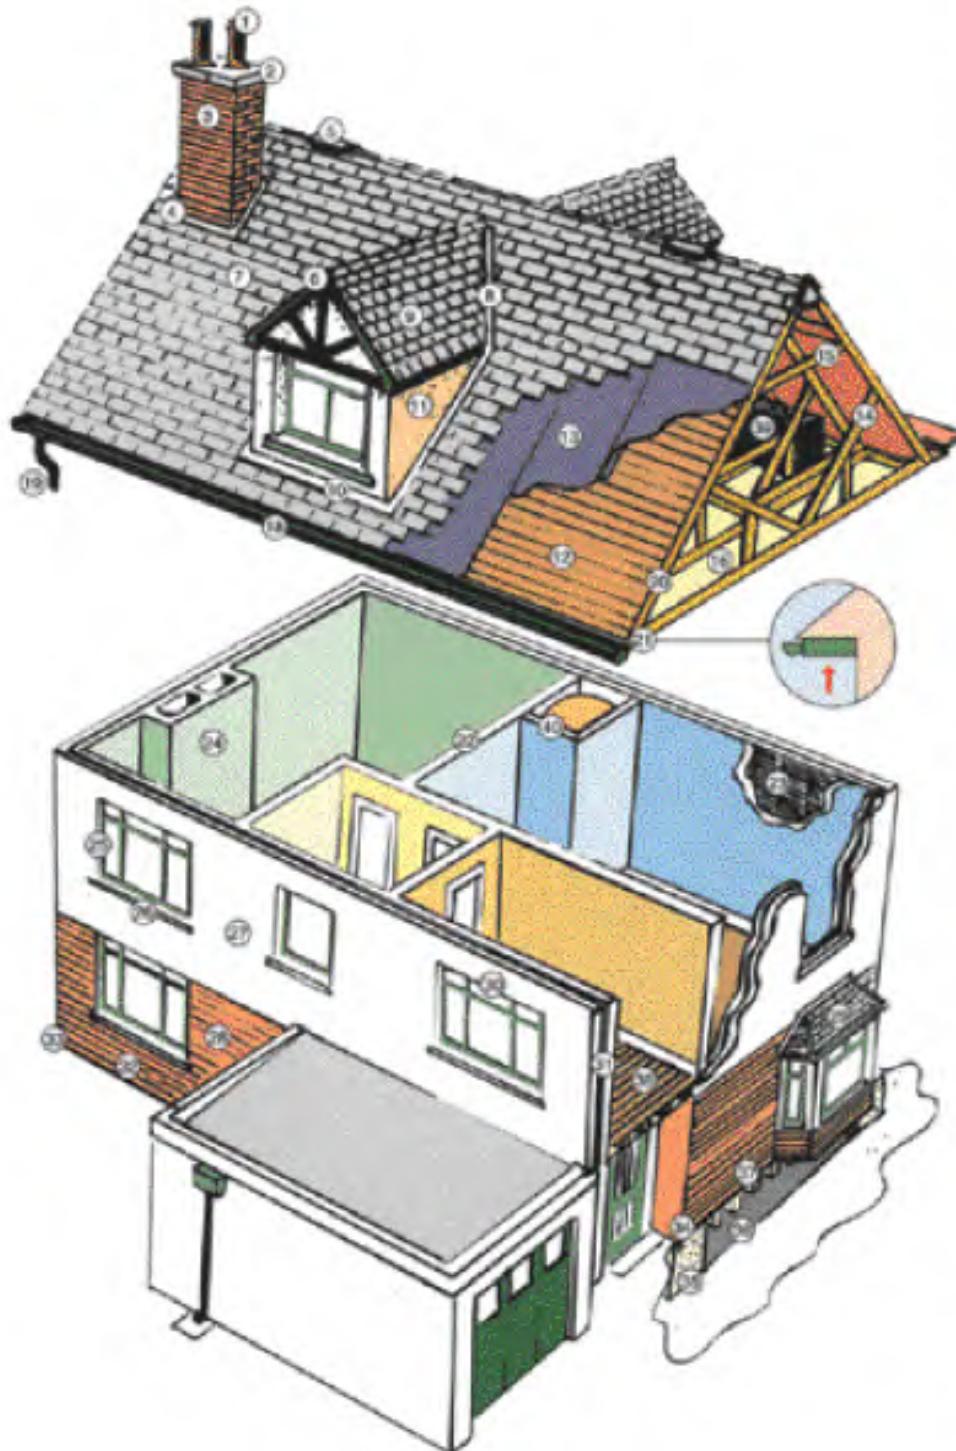
Sectional diagram showing elements of a typical house

- 1 Chimney pots
- 2 Coping stone
- 3 Chimney head
- 4 Flashing
- 5 Ridge ventilation
- 6 Ridge board
- 7 Slates / tiles
- 8 Valley guttering
- 9 Dormer projection
- 10 Dormer flashing
- 11 Dormer cheeks
- 12 Sarking
- 13 Roof felt
- 14 Trusses
- 15 Collar
- 16 Insulation
- 17 Parapet gutter
- 18 Eaves guttering
- 19 Rainwater downpipe
- 20 Verge boards / skewers
- 21 Soffit boards
- 22 Partition wall
- 23 Lath / plaster
- 24 Chimney breast
- 25 Window pointing
- 26 Window sills
- 27 Rendering
- 28 Brickwork / pointing
- 29 Bay window projection
- 30 Lintels
- 31 Cavity walls / wall ties
- 32 Subfloor ventilator
- 33 Damp proof course
- 34 Base course
- 35 Foundations
- 36 Solum
- 37 Floor joists
- 38 Floorboards
- 39 Water tank
- 40 Hot water tank

Reference may be made in this report to some or all of the above component parts of the property. This diagram may assist you in locating and understanding these terms.

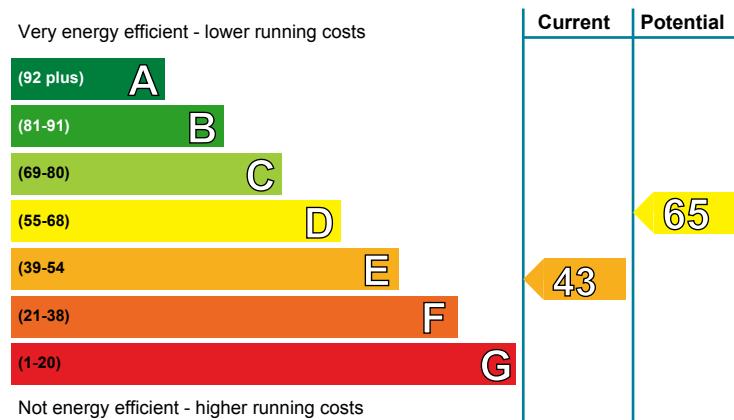
Energy Efficiency Rating

This graph shows the current efficiency of your home, taking into account both energy efficiency and fuel costs. The higher this rating, the lower your fuel bills are likely to be.

Your current rating is **band E (43)**. The average rating for EPCs in Scotland is **band D (61)**.

The potential rating shows the effect of undertaking all of the improvement measures listed within your recommendations report.

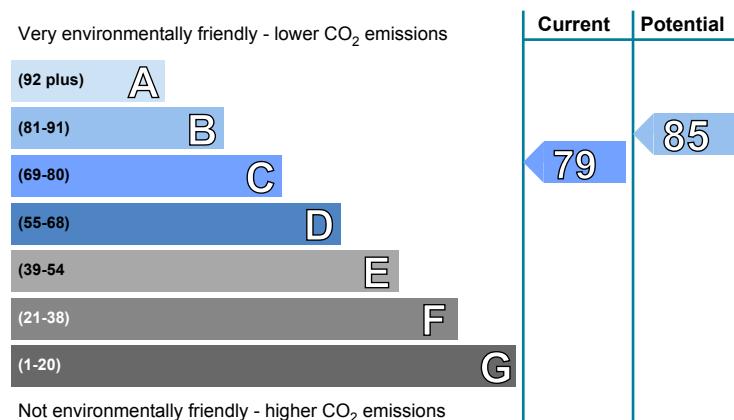
Environmental Impact (CO₂) Rating

This graph shows the effect of your home on the environment in terms of carbon dioxide (CO₂) emissions. The higher the rating, the less impact it has on the environment.
