Single Survey

Property address	North Tillykerrie, Tough, Alford, AB33 8EB
-------------------------	---

Prepared by	Allied Surveyors Scotland Ltd
--------------------	-------------------------------

Date of inspection	24th April 2026
---------------------------	-----------------

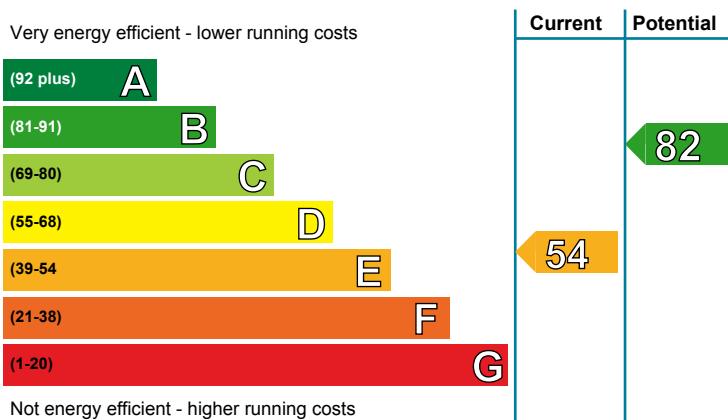
Energy Efficiency Rating

This graph shows the current efficiency of your home, taking into account both energy efficiency and fuel costs. The higher this rating, the lower your fuel bills are likely to be.

Your current rating is **band E (54)**. The average rating for EPCs in Scotland is **band D (61)**.

The potential rating shows the effect of undertaking all of the improvement measures listed within your recommendations report.

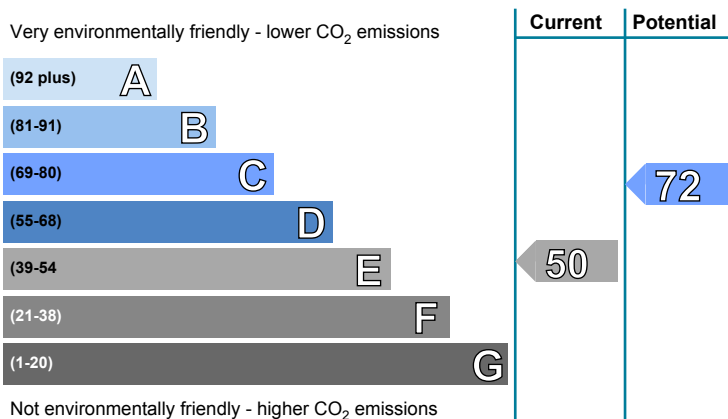
Environmental Impact (CO₂) Rating

This graph shows the effect of your home on the environment in terms of carbon dioxide (CO₂) emissions. The higher the rating, the less impact it has on the environment.

The potential rating shows the effect of undertaking all of the improvement measures listed within your recommendations report.
