Home Report

Wealthiton Croft

Single Survey and Mortgage Valuation Report

Property address	Wealthiton Croft, Keig, Alford, AB33 8BH
-------------------------	---

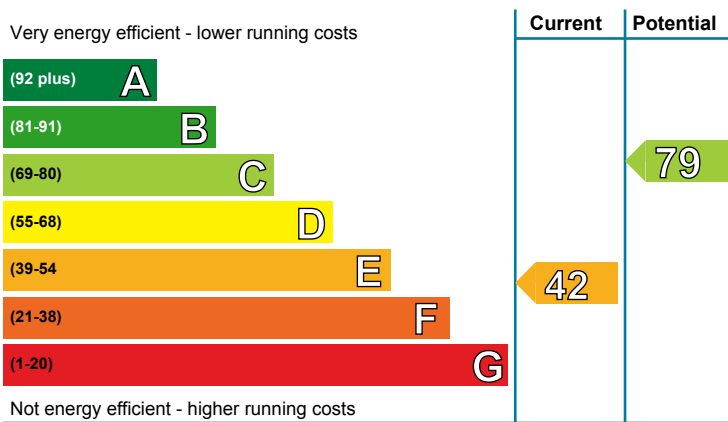
Energy Efficiency Rating

This graph shows the current efficiency of your home, taking into account both energy efficiency and fuel costs. The higher this rating, the lower your fuel bills are likely to be.

Your current rating is **band E (42)**. The average rating for EPCs in Scotland is **band D (61)**.

The potential rating shows the effect of undertaking all of the improvement measures listed within your recommendations report.

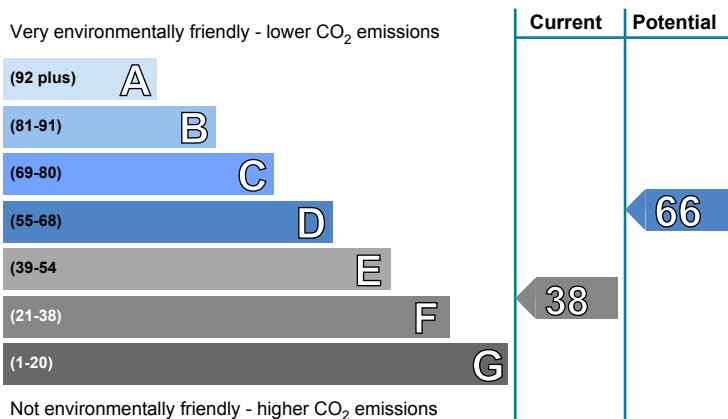
Environmental Impact (CO₂) Rating

This graph shows the effect of your home on the environment in terms of carbon dioxide (CO₂) emissions. The higher the rating, the less impact it has on the environment.

The potential rating shows the effect of undertaking all of the improvement measures listed within your recommendations report.

The average Scottish household produces about 6 tonnes of carbon dioxide every year. Based on this assessment, heating and lighting this home currently produces approximately 15 tonnes of carbon dioxide every year. Adopting recommendations in this report can reduce emissions and protect the environment. If you were to install all of these recommendations this could reduce emissions by 7.4 tonnes per year. You could reduce emissions even more by switching to renewable energy sources.
