HOME REPORT

—
9
Hunter Street
Shotts
ML7 4EE

SINGLE SURVEY

Single Survey

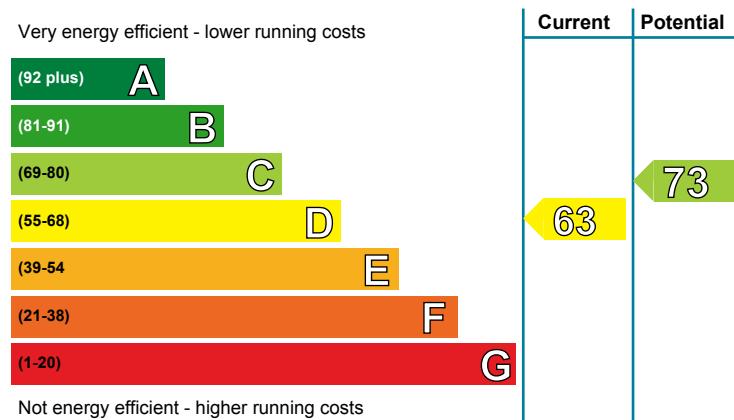
Energy Efficiency Rating

This graph shows the current efficiency of your home, taking into account both energy efficiency and fuel costs. The higher this rating, the lower your fuel bills are likely to be.

Your current rating is **band D (63)**. The average rating for EPCs in Scotland is **band D (61)**.

The potential rating shows the effect of undertaking all of the improvement measures listed within your recommendations report.

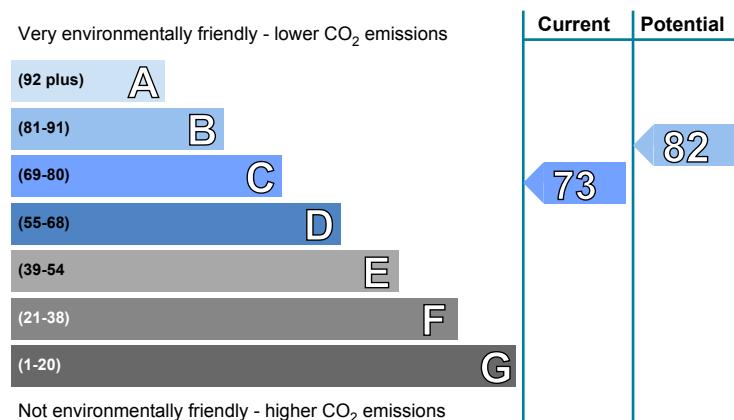
Environmental Impact (CO₂) Rating

This graph shows the effect of your home on the environment in terms of carbon dioxide (CO₂) emissions. The higher the rating, the less impact it has on the environment.
