# Energy Performance Certificate (EPC)

# Scotland

167 WOODSTOCK AVENUE, GALASHIELS, TD1 2EQ

**Dwelling type:** Mid-terrace house  
**Date of assessment:** 25 May 2026  
**Date of certificate:** 25 May 2026  
**Total floor area:** 64 m<sup>2</sup>  
**Primary Energy Indicator:** 228 kWh/m<sup>2</sup>/year

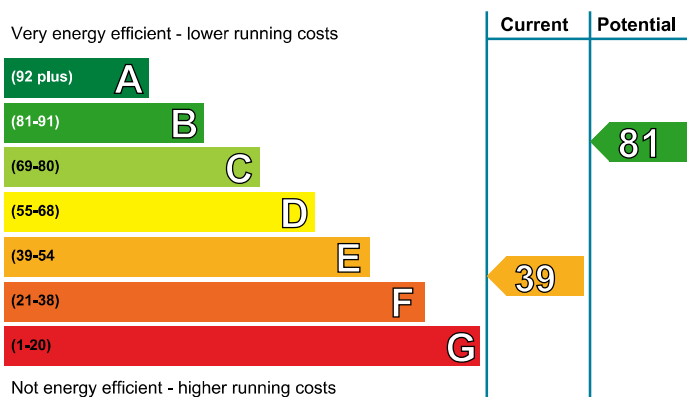
## Energy Efficiency Rating

This graph shows the current efficiency of your home, taking into account both energy efficiency and fuel costs. The higher this rating, the lower your fuel bills are likely to be.

Your current rating is **band E (39)**. The average rating for EPCs in Scotland is **band D (61)**.

The potential rating shows the effect of undertaking all of the improvement measures listed within your recommendations report.

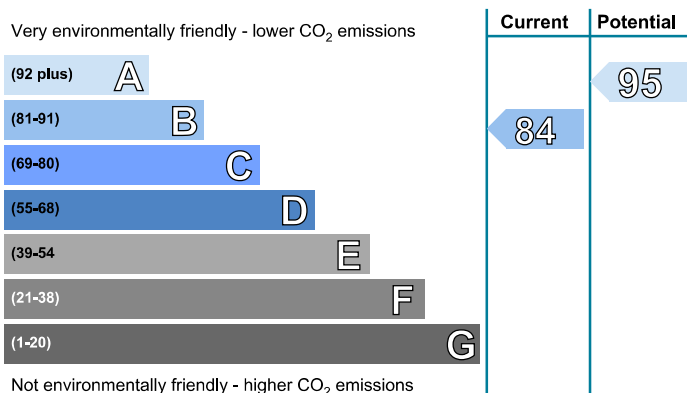
## Environmental Impact (CO<sub>2</sub>) Rating

This graph shows the effect of your home on the environment in terms of carbon dioxide (CO<sub>2</sub>) emissions. The higher the rating, the less impact it has on the environment.

Your current rating is **band B (84)**

The potential rating shows the effect of undertaking all of the improvement measures listed within your recommendations report.
