YOUR ONESURVEY  
**HOME REPORT**

6 Maisondieu Place  
Elgin  
IV30 1RD

# SINGLE SURVEY

# Single Survey

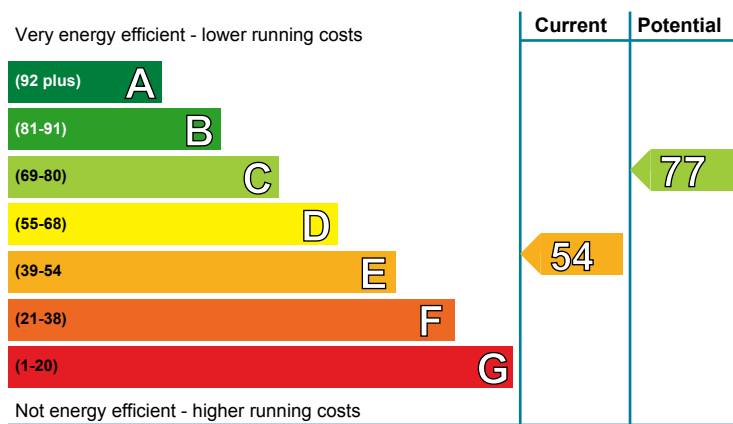
## Energy Efficiency Rating

This graph shows the current efficiency of your home, taking into account both energy efficiency and fuel costs. The higher this rating, the lower your fuel bills are likely to be.

Your current rating is **band E (54)**. The average rating for EPCs in Scotland is **band D (61)**.

The potential rating shows the effect of undertaking all of the improvement measures listed within your recommendations report.
