# Home Report

# Single Survey

<b>Property address</b>	5/2 19 Victoria Road Glasgow G42 7AB
<b>Customer</b>	Geeta Sharma
<b>Customer address</b>	5/2 19 Victoria Road Glasgow G42 7AB
<b>Prepared by</b>	Shepherd Chartered Surveyors
<b>Date of inspection</b>	02/04/2026

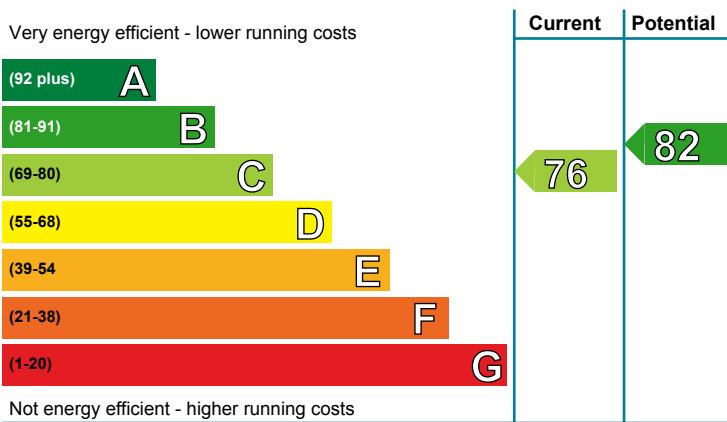
## Energy Efficiency Rating

This graph shows the current efficiency of your home, taking into account both energy efficiency and fuel costs. The higher this rating, the lower your fuel bills are likely to be.

Your current rating is **band C (76)**. The average rating for EPCs in Scotland is **band D (61)**.

The potential rating shows the effect of undertaking all of the improvement measures listed within your recommendations report.

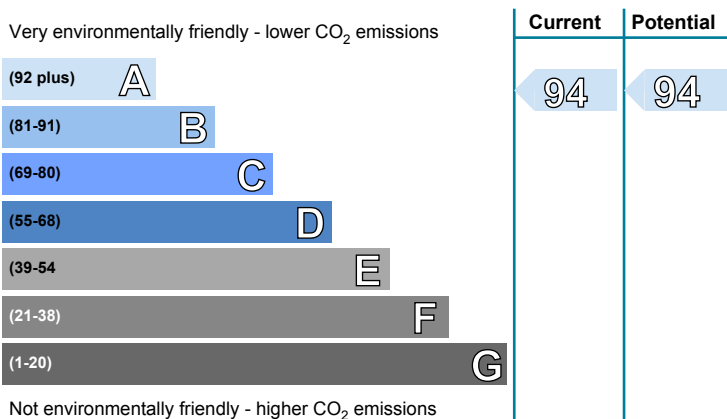
## Environmental Impact (CO<sub>2</sub>) Rating

This graph shows the effect of your home on the environment in terms of carbon dioxide (CO<sub>2</sub>) emissions. The higher the rating, the less impact it has on the environment.
