Home Report

Scottish Single Survey

Single Survey

Property address	22 Ringans Lane Stirling FK7 9DP
-------------------------	----------------------------------------

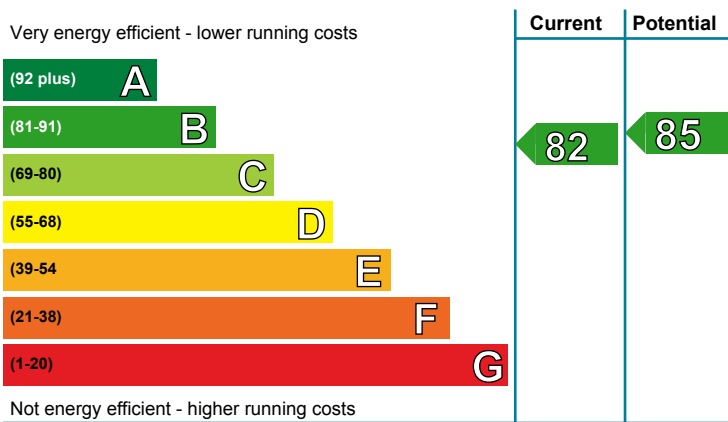
Energy Efficiency Rating

This graph shows the current efficiency of your home, taking into account both energy efficiency and fuel costs. The higher this rating, the lower your fuel bills are likely to be.

Your current rating is **band B (82)**. The average rating for EPCs in Scotland is **band D (61)**.

The potential rating shows the effect of undertaking all of the improvement measures listed within your recommendations report.
