Home Report

Moorland Hill Place

Portree
IV51 9GS

Energy Performance Certificate

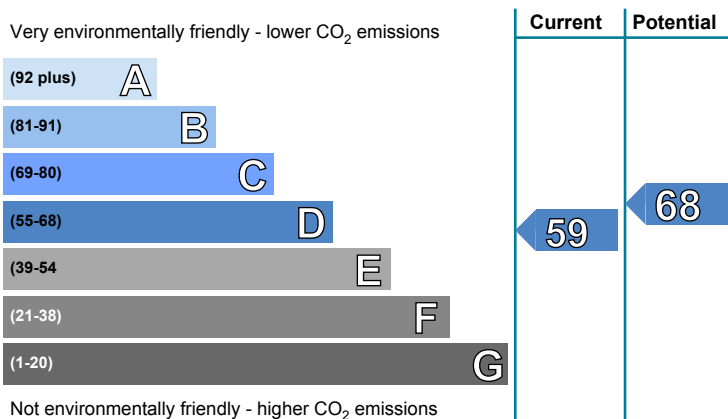
Environmental Impact (CO₂) Rating

This graph shows the effect of your home on the environment in terms of carbon dioxide (CO₂) emissions. The higher the rating, the less impact it has on the environment.

Your current rating is **band D (59)**

The potential rating shows the effect of undertaking all of the improvement measures listed within your recommendations report.

The average Scottish household produces about 6 tonnes of carbon dioxide every year. Based on this assessment, heating and lighting this home currently produces approximately 5.4 tonnes of carbon dioxide every year. Adopting recommendations in this report can reduce emissions and protect the environment. If you were to install all of these recommendations this could reduce emissions by 1.1 tonnes per year. You could reduce emissions even more by switching to renewable energy sources.
