Ranachan Cottage,
Strontian,
ACHARACLE,
PH36 4HY

Home Report

Single Survey

Property Address	Ranachan Cottage, Strontian, ACHARACLE, PH36 4HY
Reference	OB202604-56416
Customer Name	Mr. Alan Rowbottom
Date of Inspection	30th April 2026
Surveyor's name, qualifications and office	Wesley Weld-Moore, MRICS DM Hall LLP Chartered Surveyors The Oban Times Building Corran Esplanade Oban PA34 5PX
Prepared By	DM Hall LLP

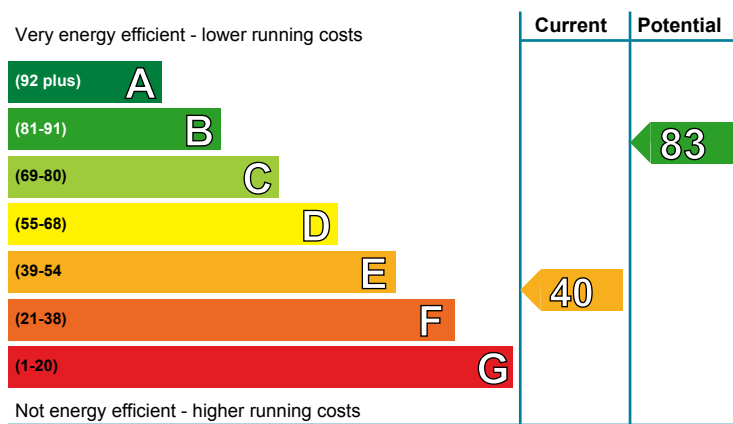
Energy Efficiency Rating

This graph shows the current efficiency of your home, taking into account both energy efficiency and fuel costs. The higher this rating, the lower your fuel bills are likely to be.

Your current rating is **band E (40)**. The average rating for EPCs in Scotland is **band D (61)**.

The potential rating shows the effect of undertaking all of the improvement measures listed within your recommendations report.

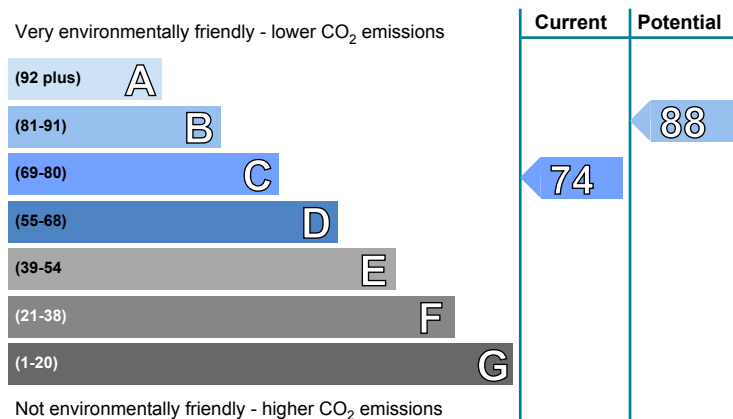
Environmental Impact (CO₂) Rating

This graph shows the effect of your home on the environment in terms of carbon dioxide (CO₂) emissions. The higher the rating, the less impact it has on the environment.
