Hillhead Croft,  
Inverfarigaig,  
Inverness,  
IV2 6XR

# Home Report

# Single Survey

<b>Property Address</b>	Hillhead Croft, Inverfarigaig, Inverness, IV2 6XR
<b>Reference</b>	1460523
<b>Customer Name</b>	Katie Walter
<b>Date of Inspection</b>	5th March 2026
<b>Surveyor's name, qualifications and office</b>	Simone Coles  DM Hall LLP Chartered Surveyors Hope House, Cradlehall Business Park, Castlehill Drive Cradlehall Inverness IV2 5GH  Tel: 01463 241077  email: invernessresidential@dmhall.co.uk
<b>Prepared By</b>	DM Hall LLP

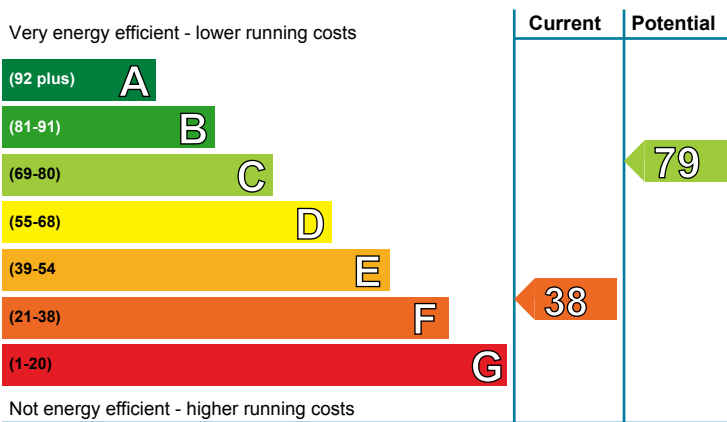
## Energy Efficiency Rating

This graph shows the current efficiency of your home, taking into account both energy efficiency and fuel costs. The higher this rating, the lower your fuel bills are likely to be.

Your current rating is **band F (38)**. The average rating for EPCs in Scotland is **band D (61)**.

The potential rating shows the effect of undertaking all of the improvement measures listed within your recommendations report.

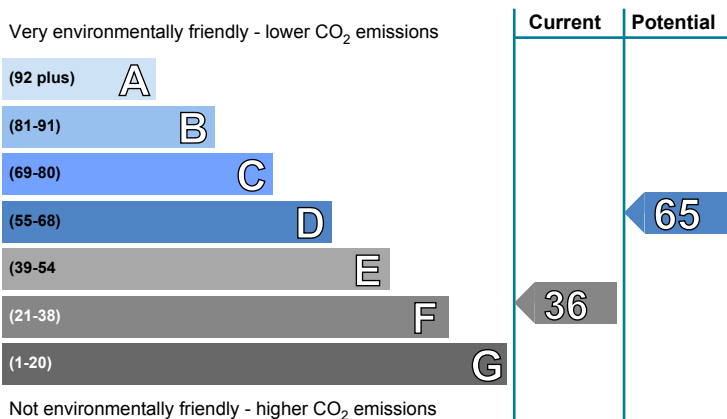
## Environmental Impact (CO<sub>2</sub>) Rating

This graph shows the effect of your home on the environment in terms of carbon dioxide (CO<sub>2</sub>) emissions. The higher the rating, the less impact it has on the environment.
