YOUR ONESURVEY
HOME REPORT

2f2
146 Morningside Road
Edinburgh
EH10 4PX

SINGLE SURVEY

Single Survey

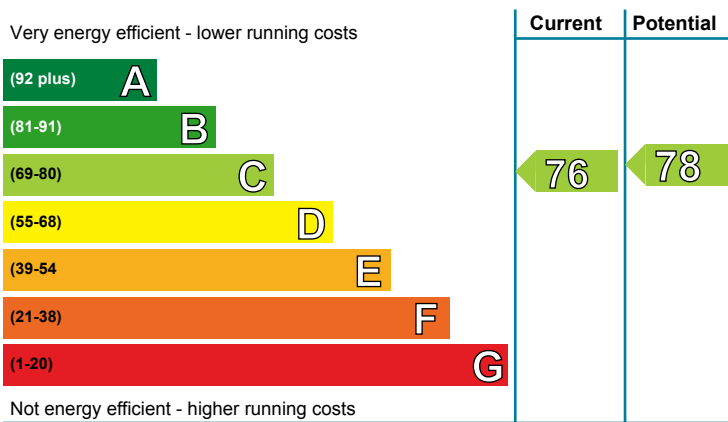
Energy Efficiency Rating

This graph shows the current efficiency of your home, taking into account both energy efficiency and fuel costs. The higher this rating, the lower your fuel bills are likely to be.
