# Home Report

# Scottish Single Survey

| Property address | The Poplars<br>Upper King Street<br>Tain<br>IV19 1AT |
| Date of inspection | 27/11/2025 |

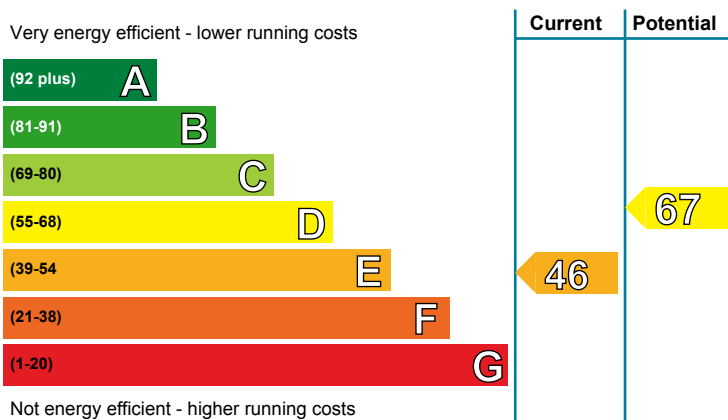
## Energy Efficiency Rating

This graph shows the current efficiency of your home, taking into account both energy efficiency and fuel costs. The higher this rating, the lower your fuel bills are likely to be.

Your current rating is **band E (46)**. The average rating for EPCs in Scotland is **band D (61)**.

The potential rating shows the effect of undertaking all of the improvement measures listed within your recommendations report.

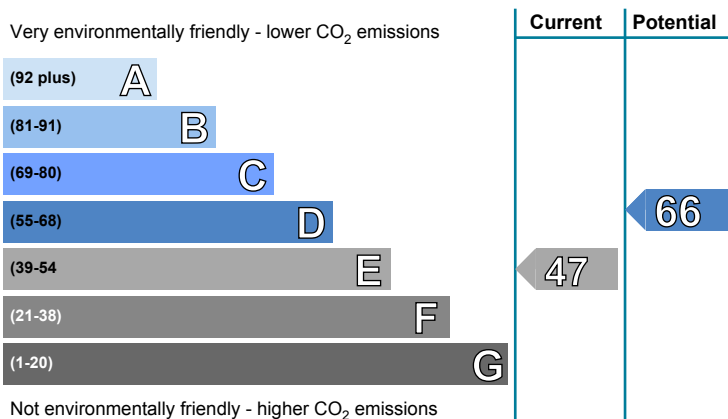
## Environmental Impact (CO<sub>2</sub>) Rating

This graph shows the effect of your home on the environment in terms of carbon dioxide (CO<sub>2</sub>) emissions. The higher the rating, the less impact it has on the environment.
