Home Report

Flat 4 Bruce Court Links Parade
Carnoustie DD7 7JE

Single Survey

Property Address	Flat 4 Bruce Court Links Parade Carnoustie DD7 7JE
Customer	Craig & Pauline Murray
Prepared by	Graham + Sibbald Property Consultants Limited
Date of Inspection	09/04/2026

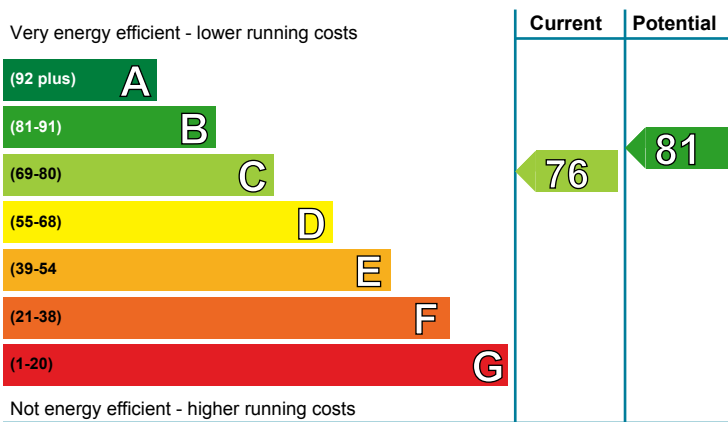
Energy Efficiency Rating

This graph shows the current efficiency of your home, taking into account both energy efficiency and fuel costs. The higher this rating, the lower your fuel bills are likely to be.

Your current rating is **band C (76)**. The average rating for EPCs in Scotland is **band D (61)**.

The potential rating shows the effect of undertaking all of the improvement measures listed within your recommendations report.

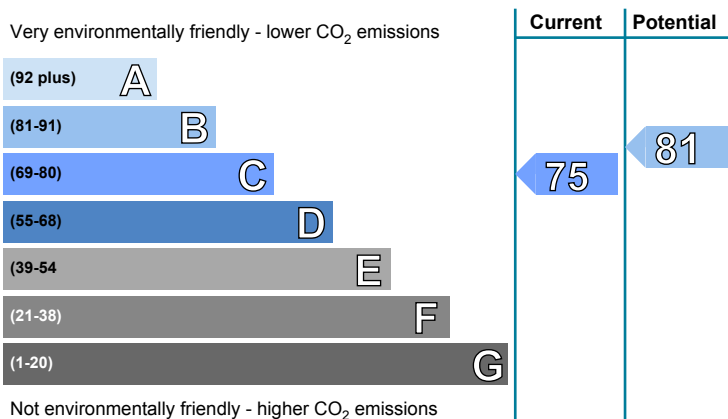
Environmental Impact (CO₂) Rating

This graph shows the effect of your home on the environment in terms of carbon dioxide (CO₂) emissions. The higher the rating, the less impact it has on the environment.
