YOUR ONESURVEY
HOME REPORT

12 Blair Grove
Blairhall
Dunfermline
KY12 9LG

SINGLE SURVEY

A report on the condition of the property, with categories being rated from 1 to 3.

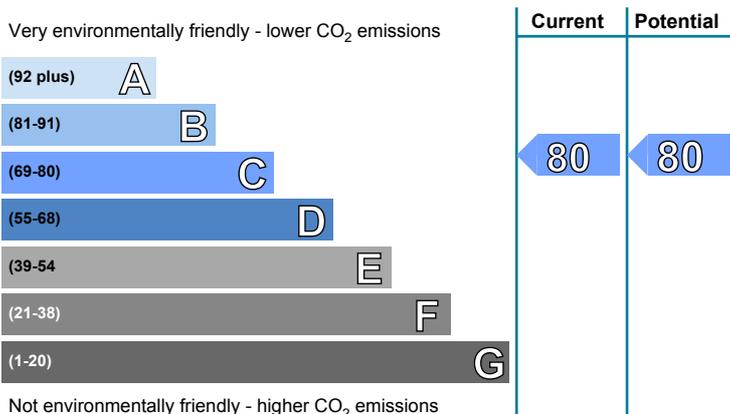
Environmental Impact (CO₂) Rating

This graph shows the effect of your home on the environment in terms of carbon dioxide (CO₂) emissions. The higher the rating, the less impact it has on the environment.
